April 26, 2016  
Rincon Project No. 11-98490

**Subject: Arborist Letter Report for the Imel Property of the Orcutt Area Specific Plan, San Luis Obispo, California**

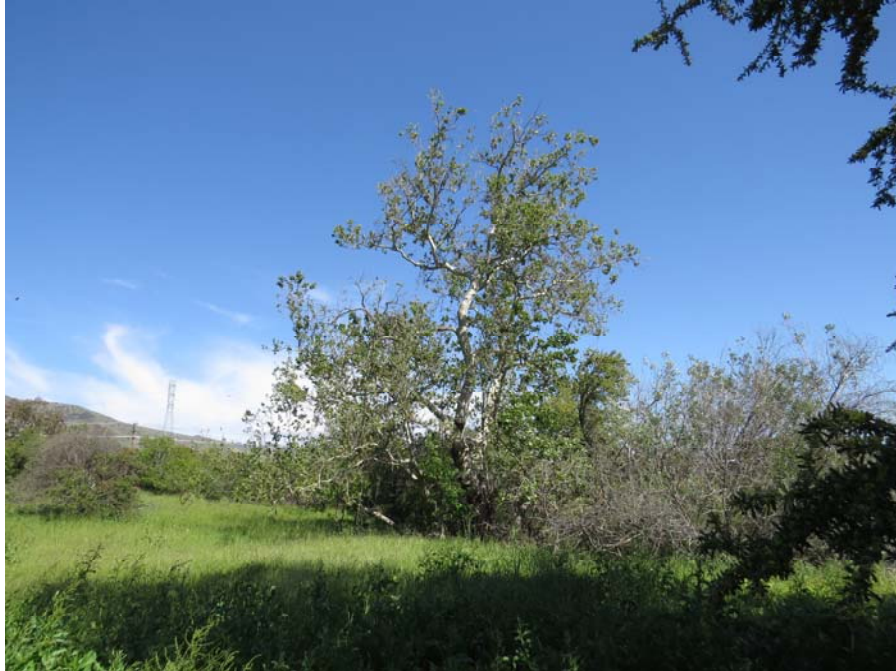
Crotalo Creek runs along the southern edge of Imel Property. The tree canopy along the creek is fairly dense and consists primarily of California walnut (*Juglans californica*), willow (*Salix* spp.), and coast live oak (*Quercus agrifolia*) with several other riparian species scattered throughout. In general, the trees in this area are in fair health, but individually vary from good to poor health. Many trees have signs of rot at the base of their trunks or show evidence of past trimming. Proposed impacts to trees in Crotalo Creek are limited to trimming of a coast live oak (No. 532) and a California sycamore (*Platanus racemosa*; No. 539). The coast live oak has a dbh of 14 inches and leans strongly outside of the creek where much of its canopy rests on the ground. This tree is in poor overall condition and with the canopy resting on the ground it is especially vulnerable to pests. The proposed trimming includes removing limbs that extend from the creek into the project footprint. The sycamore is a large tree with five trunks ranging from 10 to 53 inches dbh, and a canopy 55 feet tall and 60 feet wide. The tree is in fair overall health, but the main trunk has visible fungus infestation. One of the five trunks extends away from the main tree axis and into the project footprint. This trunk is proposed for trimming. If trimming is conducted to ISA standards and with recommendations made below, the tree can be trimmed without causing mortality and retained on site.

Photo 1. View east of California sycamore (No. 539) proposed for trimming.

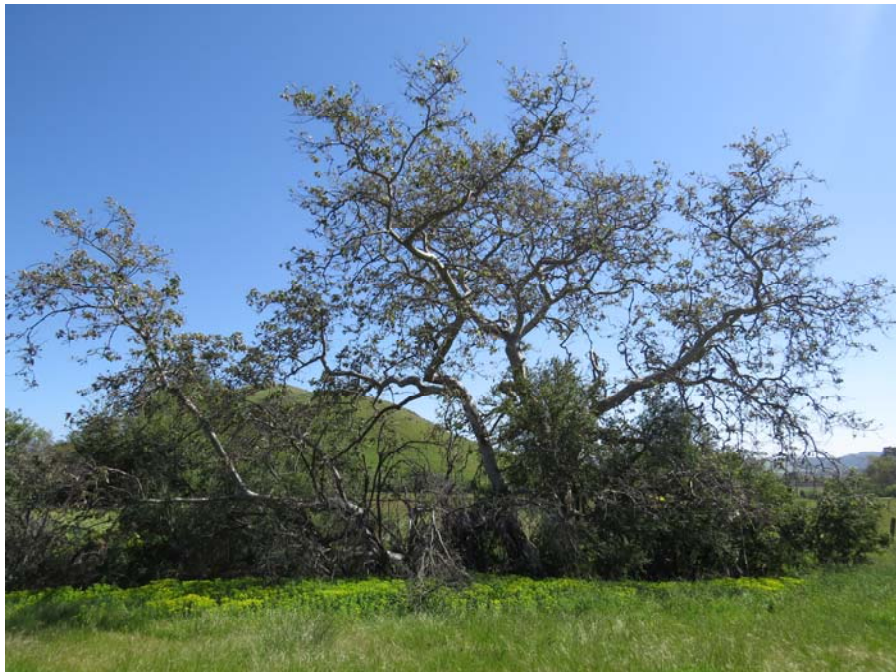
Tanglewood creek runs across the center portion of the Imel Property. In the downstream portion of Tanglewood Creek, a cluster of non-native Chilean pepper trees (*Schinus polygamus*; part of grove No. 547) and a single California sycamore (No. 548) are proposed for removal. The Chilean pepper trees are located within and along the creek channel and are generally small; ranging from approximately 6-10 inches dbh and up to 15 feet tall. They are in fair overall condition with relatively full canopies. The sycamore is situated within the channel of the creek. It is a large sprawling tree with a dbh of 61 inches and several major branches that flair out of the main trunk. The canopy reaches approximately 60 feet high and approximately 70 feet across. The tree is senescent (aged and becoming overly mature) and in overall poor condition. The trunk is in poor health with visible rot damage from the ground to approximately 15 feet and a colony of ants was infesting the base at the time of the assessment survey. The limbs are also in poor health and show signs of overextension. The canopy is in poor health as well, with signs of systemic disease as evidenced by substantial leaf burn throughout the canopy. Additionally, the foliage was generally much sparser than other sycamores on the Imel Property and surrounding properties. The proposed project footprint crosses Tanglewood Creek immediately upstream of the sycamore. As such, one of the overextended limbs will need to be removed and a large portion of the tree's root zone will be disturbed.

Photo 2. View southeast of California sycamore (No. 548) proposed for removal.

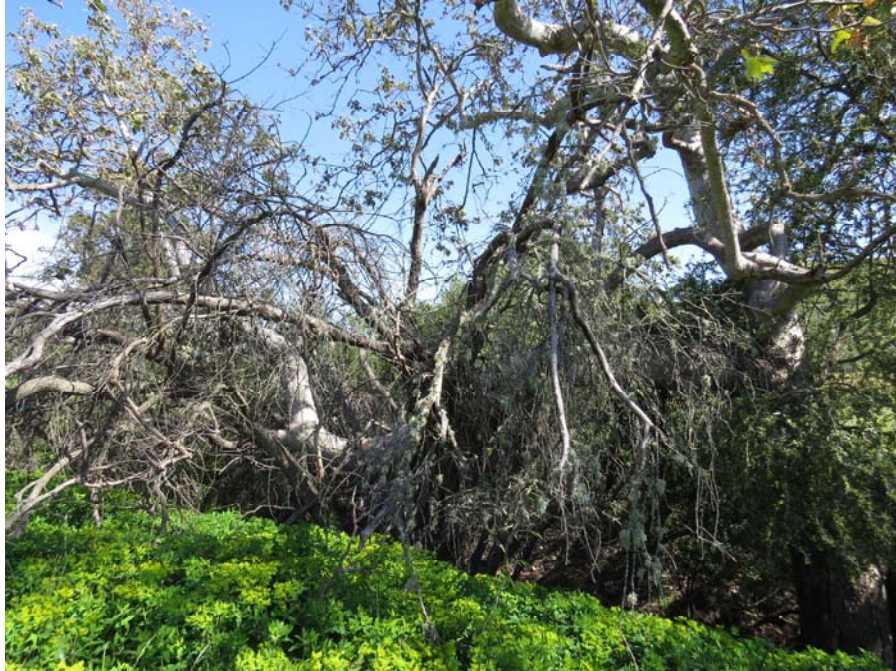
Photo 3. Close-up view of California sycamore (No. 548) showing poor health of branches and canopy including sparse foliage and leaf burn.

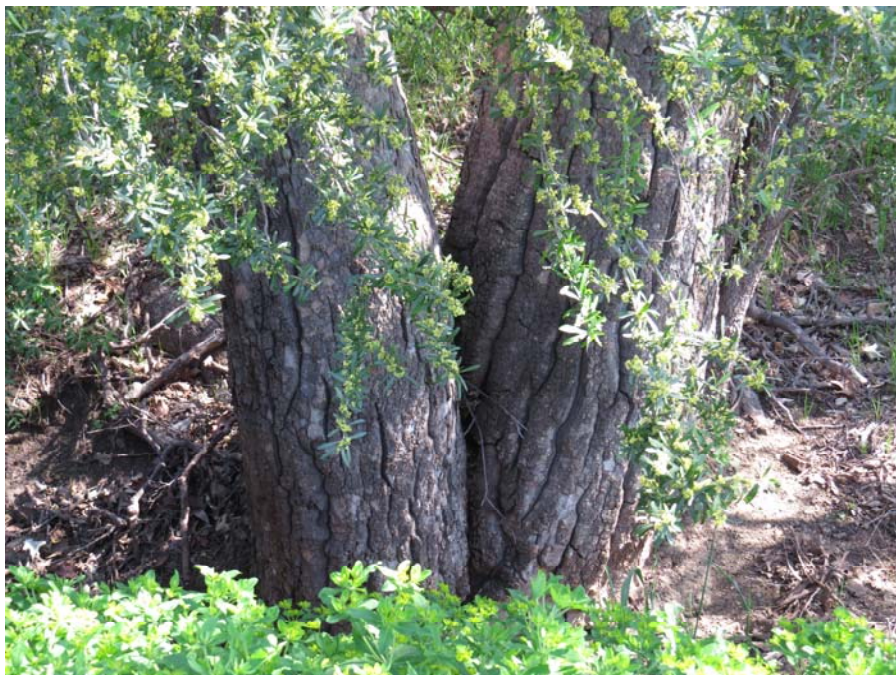
Photo 4. Close-up of trunk of California sycamore (No. 548) showing poor health and evidence of substantial rot.

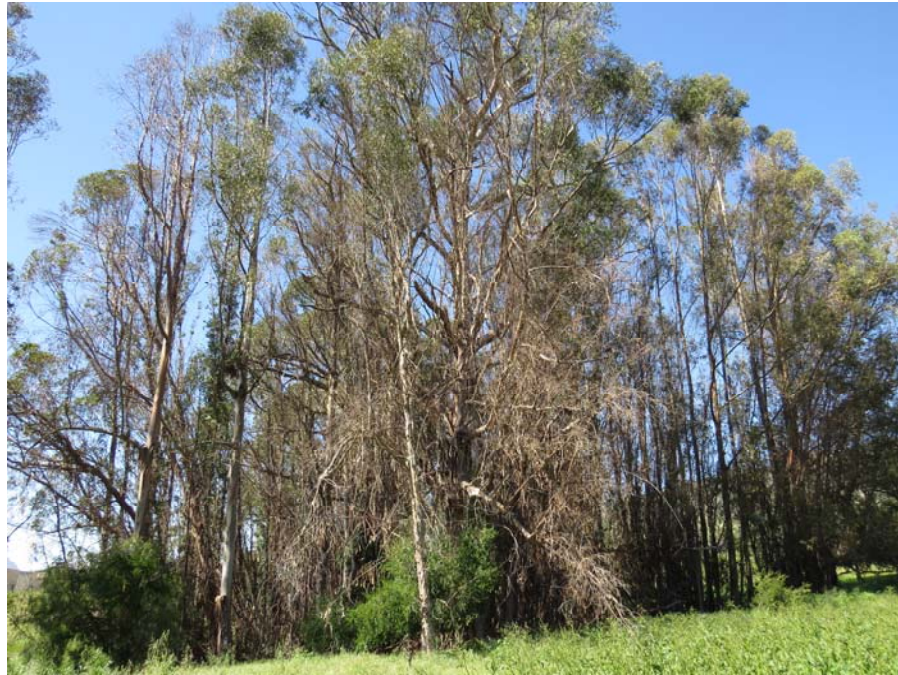
A portion of the upper reach of Tanglewood Creek is dominated by a large grove of blue gum (*Eucalyptus globulus*; No. 560). This grove consists of over 50 trees of various sizes and ages with a canopy approximately 220 feet wide and 100 feet tall. The overall condition of the grove is poor with several dead individuals along the periphery and many more fallen

within the grove. The trees generally contain dead branches and excessive sloughing bark. The majority of the trees in the grove are proposed for removal with the exception trees that are located within the creek channel.

Photo 5. View north of the blue gum grove (No. 560) along Tanglewood Creek. The majority of this grove is proposed for removal.
