Rincon Consultants, Inc.

January 10, 2017
Rincon Project Number: 16-03127

Subject: Arborist Report for the 71 Palomar Avenue Project for the City of San Luis Obispo

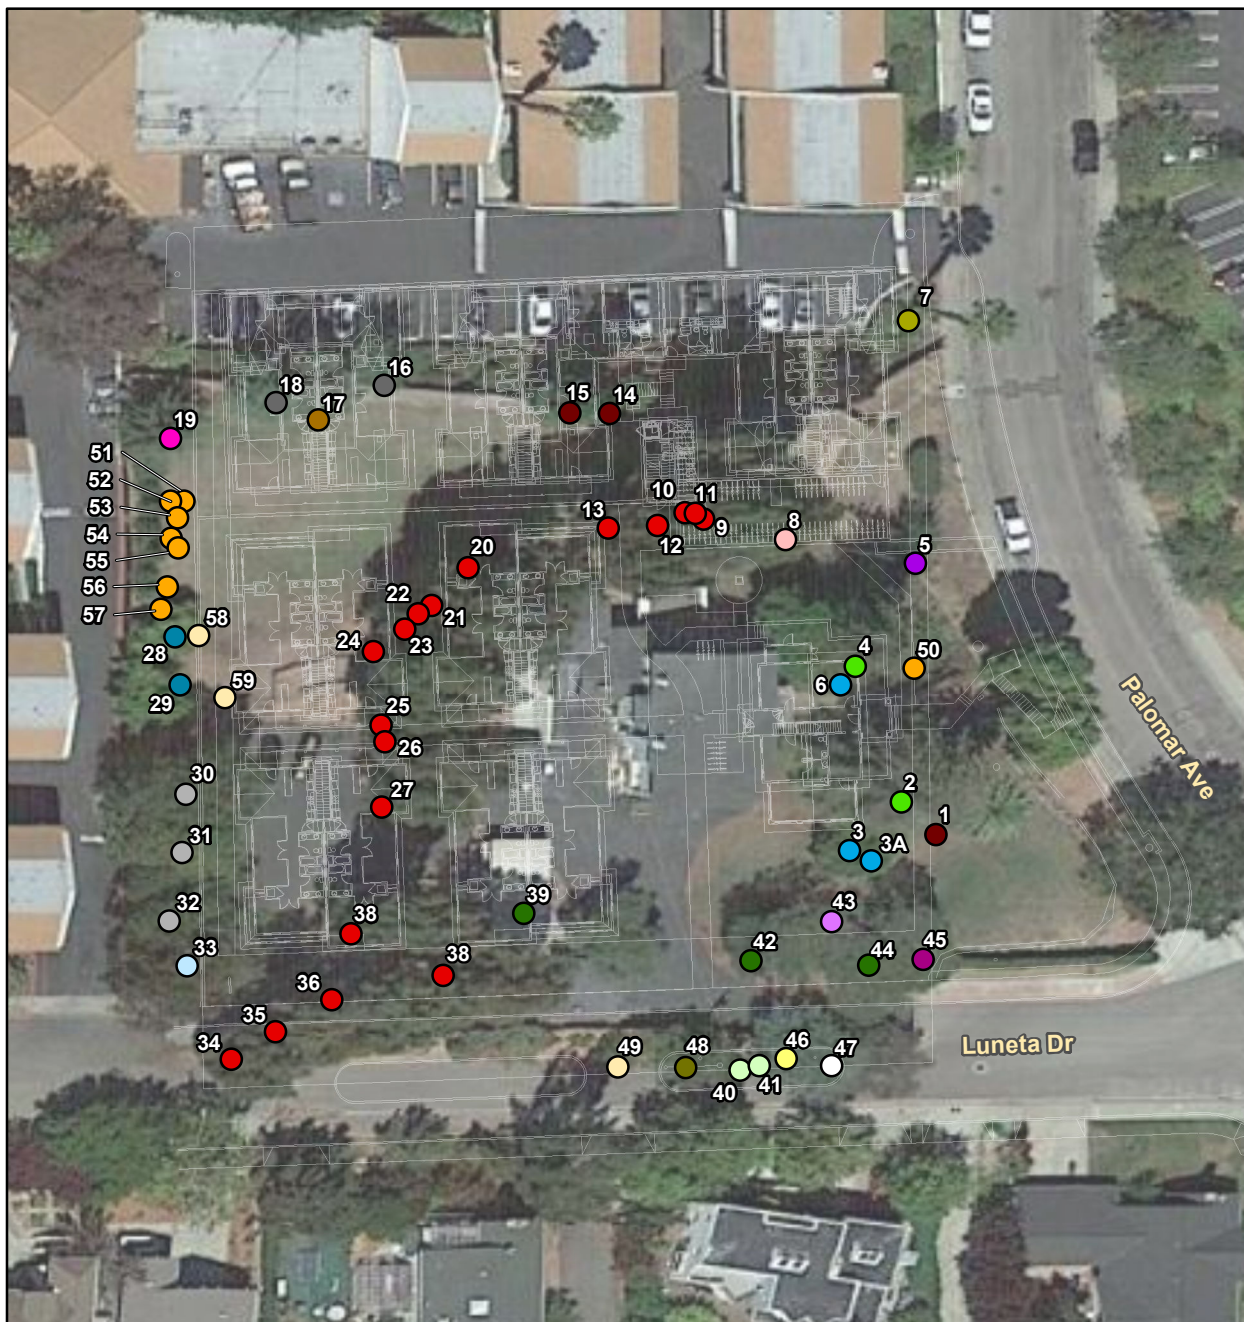
Figure 1
 Rincon Consultants, Inc.

Tree Locations
