ANALYSIS OF HISTORIC STRUCTURES

FROOM RANCH

12165 LOS OSOS VALLEY ROAD
SAN LUIS OBISPO, CA

June 30, 2017

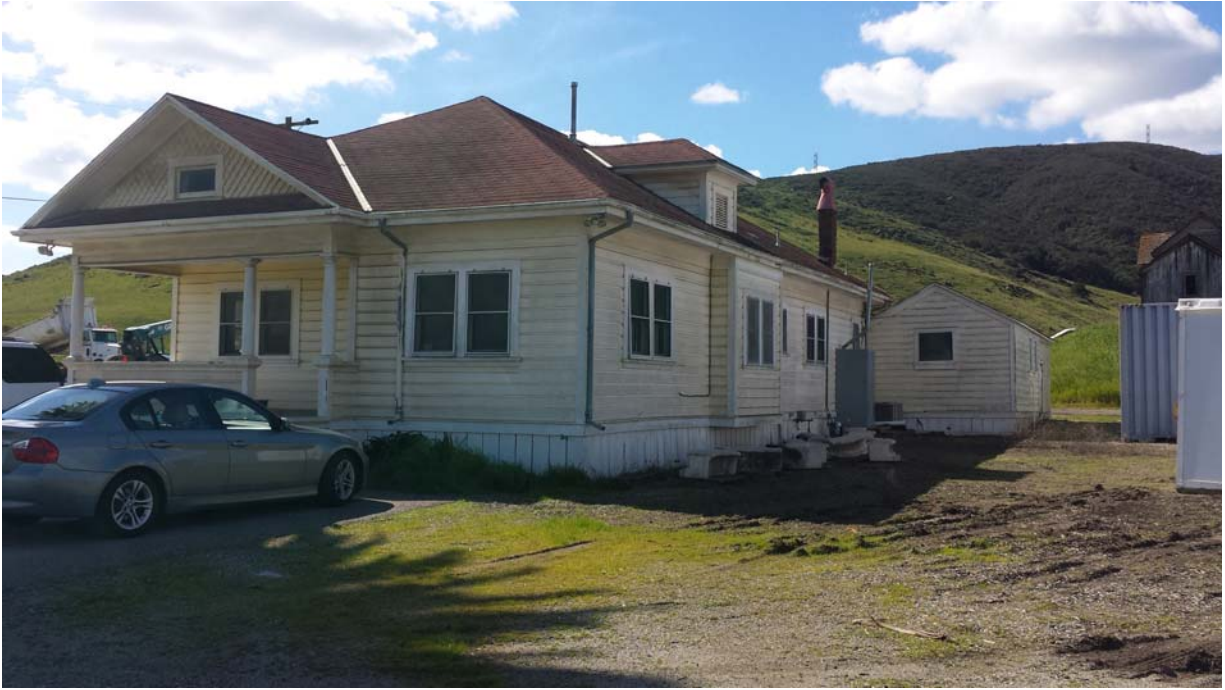
Figure 1 – Main House

The Main Residence [Figure 1] was constructed in 1915, and has been occupied continuously for use as both a residence and an office building. The approximately 1,600 SF one-story wood-framed structure appears to be in good condition, and has undergone several renovations and repairs throughout its history. The majority of the structural framing is original, however concrete foundations have been added at certain locations around the perimeter where excessive settlement has occurred. The lateral load-resisting system consists of wood siding over straight-sheathed exterior wood stud shear walls.

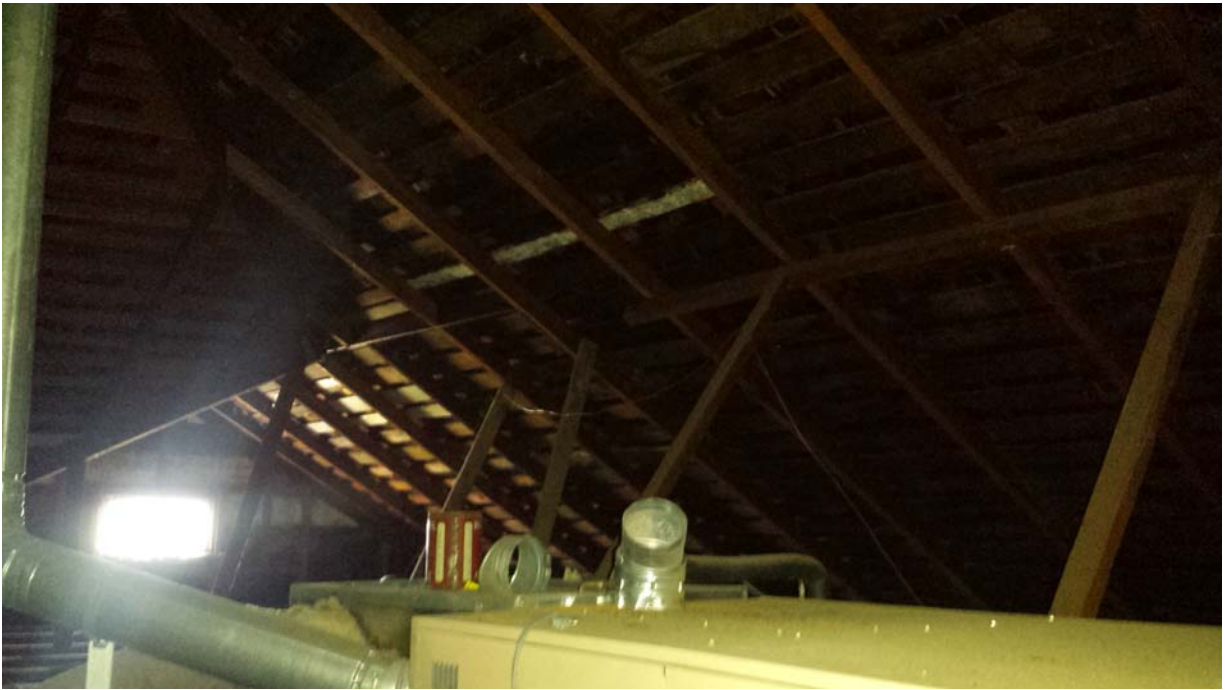
The roof framing consists of consists of composite shingles over the original wood shakes over 1x6 skip sheathing supported by 2x4 roof joists at 30" spacing. The roof joists are braced mid-span with kickers down to interior stud walls below [Figure 2]. Although the existing roof framing appears to be in good condition, there is no recognized diaphragm system needed to resist lateral loads.

Figure 2 – Main House roof joists w/ mid-span bracing

Continued Private Commercial Use – If the structure will continue to be used for private commercial purposes, the building code does not require any upgrades to the roof framing system. It is recommended, however that the next time the roof is replaced, the original wood shakes be removed, and a layer of plywood added over the existing 1x skip sheathing. The layer of plywood, if detailed and nailed properly, will act as a structural diaphragm. Additional wood blocking and metal framing clips will also be required to tie the roof diaphragm to the exterior walls below. It should also be noted that if a new roofing material is selected that is

For Use as Public Space – If the structure is to be used for public occupancy, the existing roofing shall be removed and the plywood, blocking and framing clips added as described above.

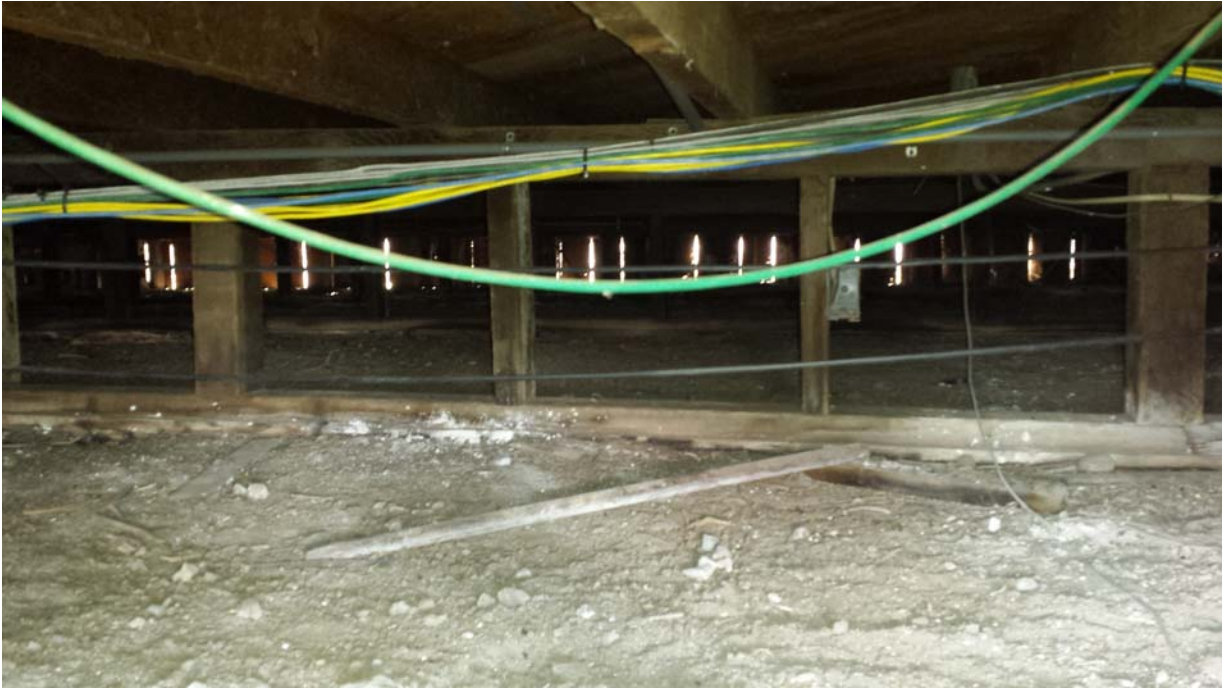
The first floor is constructed of wood flooring over 1x6 diagonal sheathing over 2"x5-1/2" wood floor joists spaced at 24". The wood floor joists span across unbraced wood cripple walls below spaced at approximately 7'-6" [Figure 3]. The 2x redwood sill of the cripple wall bears directly on grade. Releveling of the first floor has been performed several times throughout the life of the structure.

The foundation consists of interior and exterior 2x wood stud cripple walls bearing on an existing wood sill placed directly on grade [Figure 3]. Where past excessive settlement has occurred, an undocumented concrete foundation was poured below the sill to provide a greater bearing surface and better long-term durability. The exterior cripple walls are lightly braced with occasional 1x diagonal boards, while the interior cripple walls are completely unbraced.

Figure 3 – Unbraced wood cripple wall with redwood sill

Continued Private Commercial Use – If the structure will continue to be used for private commercial purposes, as a minimum both the exterior and interior cripple wall systems should be strengthened. This can be done with either a system of properly detailed diagonal boards or a pattern of plywood sheathing. Where concrete foundations have been added in previous repairs, it should be verified that the wood sills are properly anchored to the concrete. Because the existing structure bears directly on top of the soil and proper concrete foundation embedded into the soil are not present, sliding of the structure during a large earthquake could occur. Although life-safety does not appear to be a significant risk assuming the cripple wall bracing is installed, non-structural damage to interior furnishings and equipment is likely. In addition, attention should be given if future unevenness in the floor surface is encountered. This could be an indication of excessive settlement in the foundation. For better long-term structural performance, see “For Use as Public Space” below.

For Use as Public Space – If the structure is to be used for public occupancy, a proper concrete foundation should be installed. To install the concrete foundation, the structure is jacked up, continuous trenches are dug below the exterior and interior cripple walls, and concrete footings are poured. The structure is then lowered and bolted to the concrete. In addition to the footings, all cripple walls require bracing as described above.

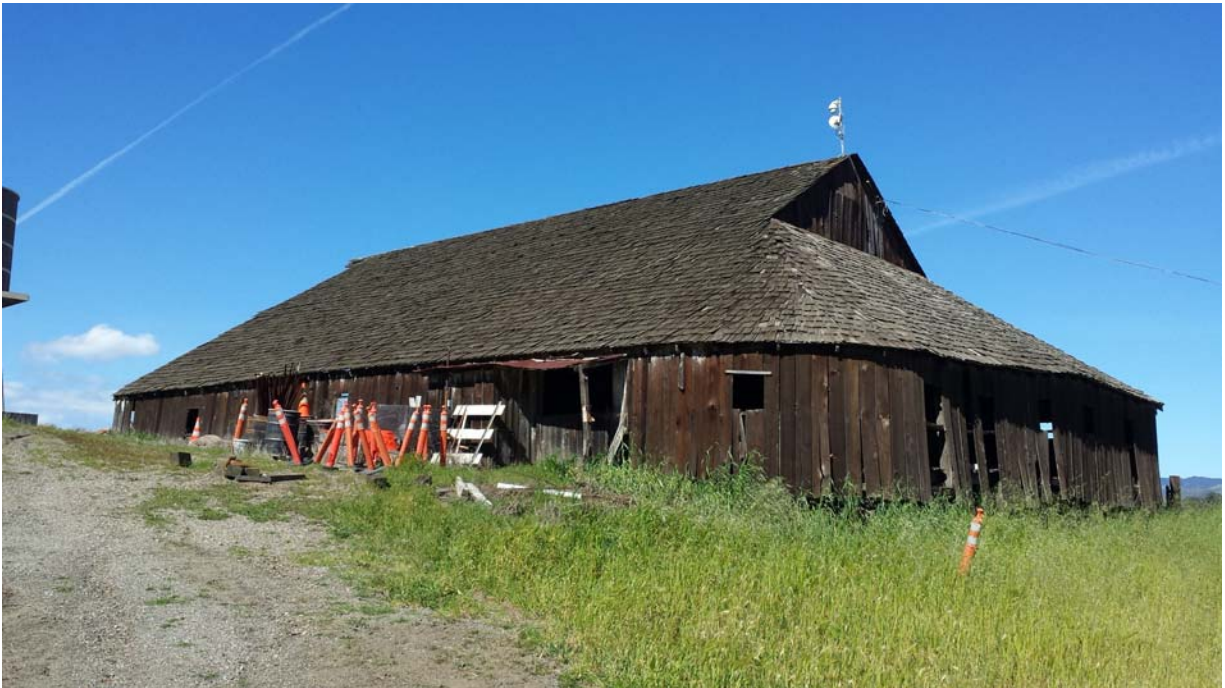
Figure 4 – Dairy (Round-Nosed) Barn

The Dairy Barn [Figure 4] is an approximately 4,200 SF wood-framed farming facility built in 1913 to house livestock and hay. Weather and neglect has severely deteriorated many of the barn's key structural elements over the course of its history. In addition, a significant portion of the barn is located within the rupture zone setback of a potentially active trace fault. These items are discussed below and shall be addressed in the renovation along with the strengthening of the lateral load-resisting system.

If left in its current location, it is recommended that the round-nosed portion of the barn be removed, in addition to the next three adjacent bays of framing, essentially cutting the structure in half. Also requiring demolition due to its proximity to the fault line is the northern masonry addition to the barn. Because the round-nosed portion of the building is unique and has historical significance, a portion of the demolished materials may be salvaged to rebuild the round-nosed portion at the eastern end of the structure. It is estimated that approximately 75% of the roof framing and 50% of the floor framing will be good for re-use. Nearly all the exterior siding is in such a state of decay that it will have no structural value. This remediation is required to ensure the safety of the occupants during a large seismic event. The rebuilt round-nosed portion will require a modern concrete foundation system to prevent the type of settling and deterioration that is currently present.

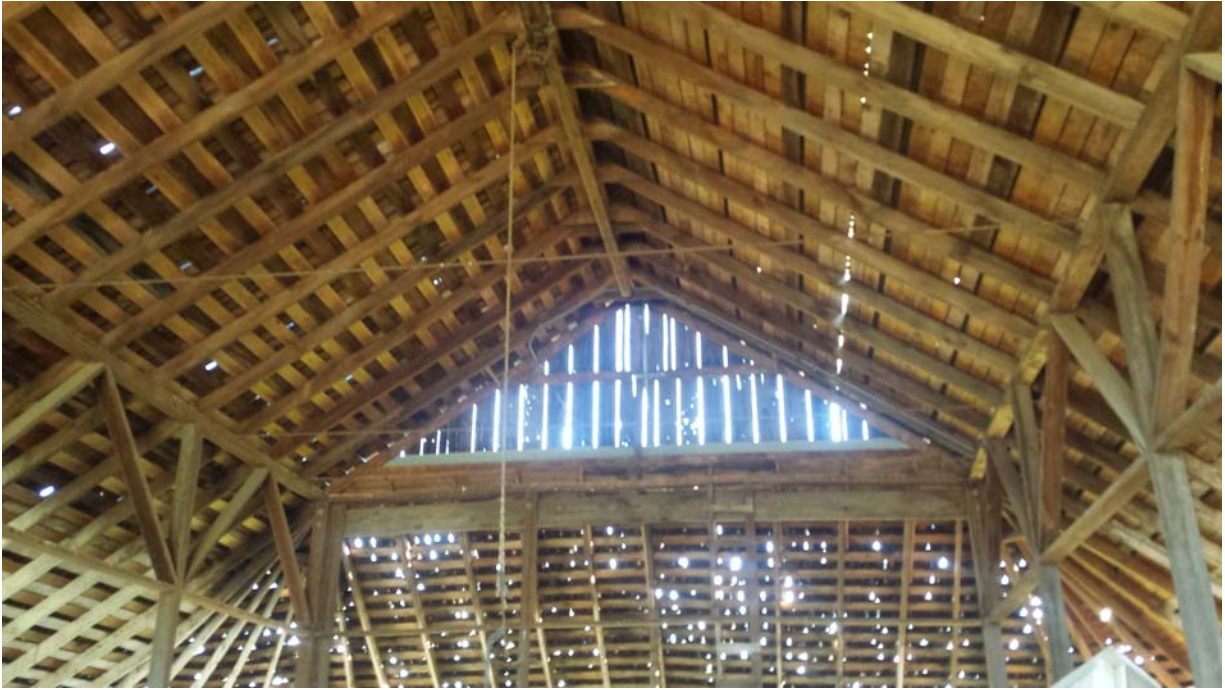
The existing roof framing [Figure 5] consists of wood shingles over 1x6 skip sheathing supported by 2"x6" roof joists at 30" spacing. A collar tie system consisting of tension rods at 10'-0" spacing thru the double top plate at the two interior post lines is present to resist the horizontal thrust. The majority of the roof framing has the capacity to resist code-level dead and live loads. The existing skip sheathing provides minimal lateral stiffness lateral stiffness, and will not act as a proper roof diaphragm.

Figure 5 – Dairy Barn roof framing

Occupancy less than 2,000 cumulative man-hours per year (tours, exhibits, etc.) – Because the existing wood shingles are in a serious state of deterioration, much of the roof framing is exposed to weather. It is recommended that the existing roofing be removed and all framing be inspected for damage. It is estimated that approximately 10% of the roof framing will need replacing. It is possible that lumber salvaged from the seismic remediation described above may be reused for this purpose. Additionally, a layer of plywood will be required over the skip sheathing in order to create a roof diaphragm. The entire roof shall be re-roofed with a light weight standing seam or corrugated metal roof with better long-term performance.

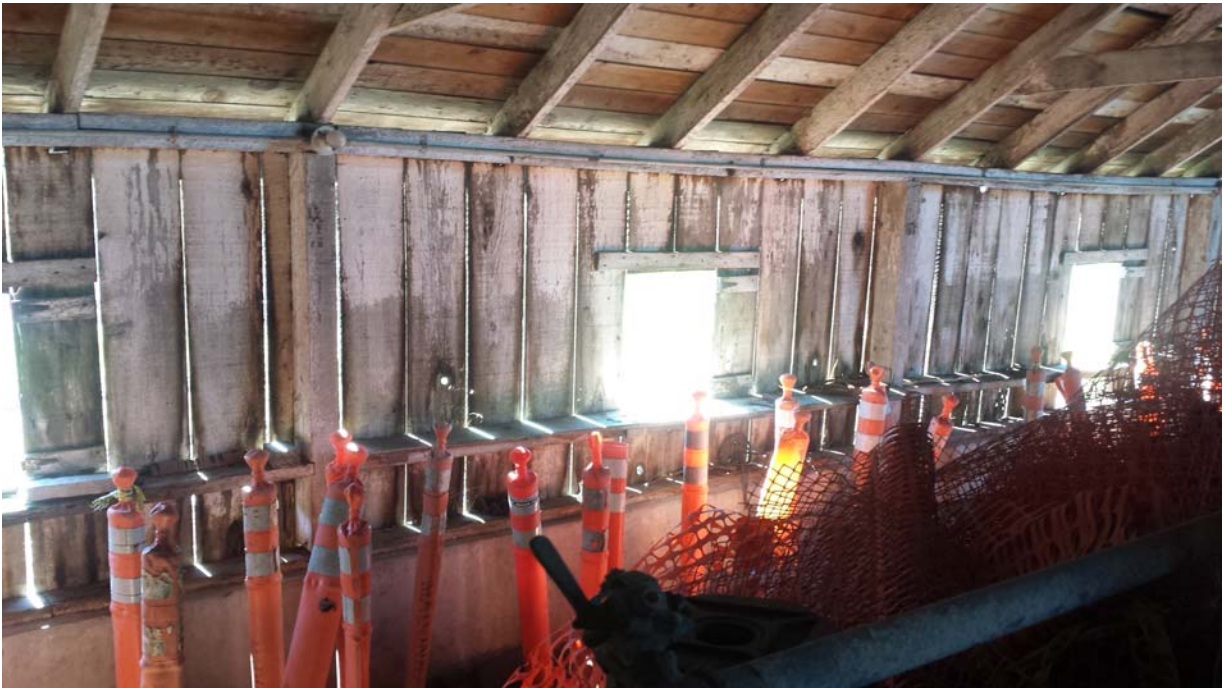
The exterior walls [Figure 6] are typically constructed with 1x12 vertical siding spanning from the double top plate to the wood sill, with an intermediate horizontal 2"x4" girt mid span. The double top plate and girt span horizontally to 4"x4" wood posts at 10'-0" spacing around the perimeter.

The majority of the perimeter foundation consists of a 24" high concrete stem or retaining wall [Figure 6] with an undetermined footing depth. The concrete foundation appears to be in good condition for the age of the structure. The majority of the foundation damage has occurred at the eastern downhill portion of the structure at the round-nosed area of the barn. The foundation system at the interior post line appears to be a redwood sill bearing directly on the soil, or else the wood posts are embedded directly into the soil [Figure 9]. The posts appear to have settled over time approximately 2".

Figure 6 – Dairy Barn exterior wall framing

Occupancy less than 2,000 cumulative man-hours per year (tours, exhibits, etc.) – The exterior vertical siding is required to be in good condition to allow for adequate nailing. Proper nailing is essential for shear wall performance. Because of years of neglect, it is estimated that up to 75% of the wood siding will need to be removed and replaced for the wood shear wall system. It is also estimated that approximately 10% of the wall framing will require replacement due to weather intrusion at the damaged siding. The entire exterior will require re-painting to help preserve the condition of the wood.

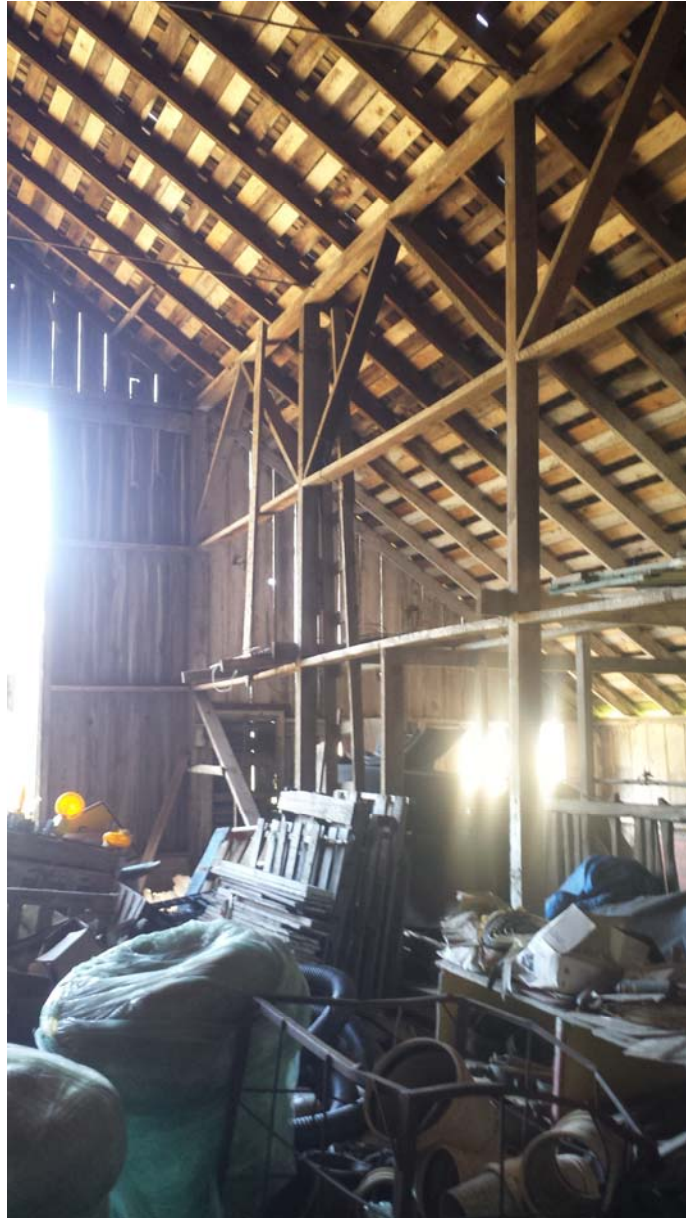
At the main western entrance to the Dairy Barn, not enough wall length existing to provide adequate lateral stiffness [Figure 7]. At this location, as well as at the two interior lines of posts [Figure 8], diagonal wood wall bracing will be required. All connections will be designed to be bolted and hidden. The bottom ends of the bracing will be required to be anchored to the existing foundation

Figure 7 – Lack of wood bracing at main western entrance to the Dairy Barn

Occupancy less than 2,000 cumulative man-hours per year (tours, exhibits, etc.) – Install new 4x4 wall braces at the western wall and at the two interior lines of posts. Strengthen all brace connections and splices with steel plates and bolts. Anchor braced connections to new concrete pad foundation.

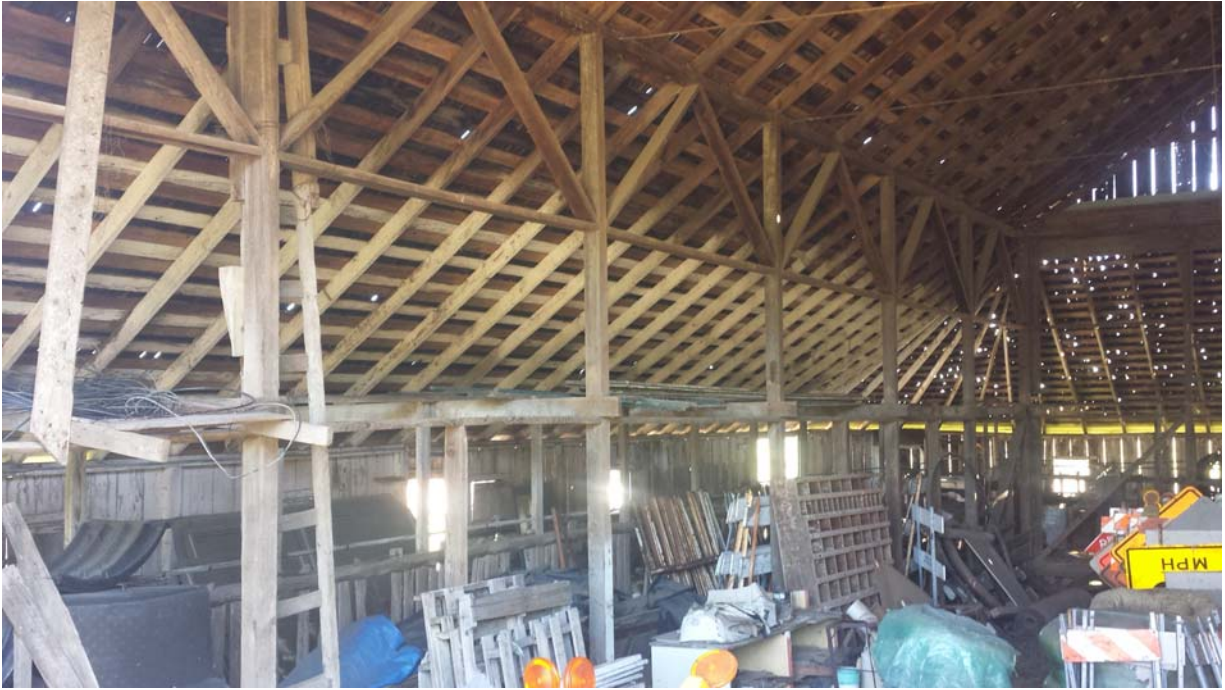
Figure 8 – Bracing at interior line of wood posts

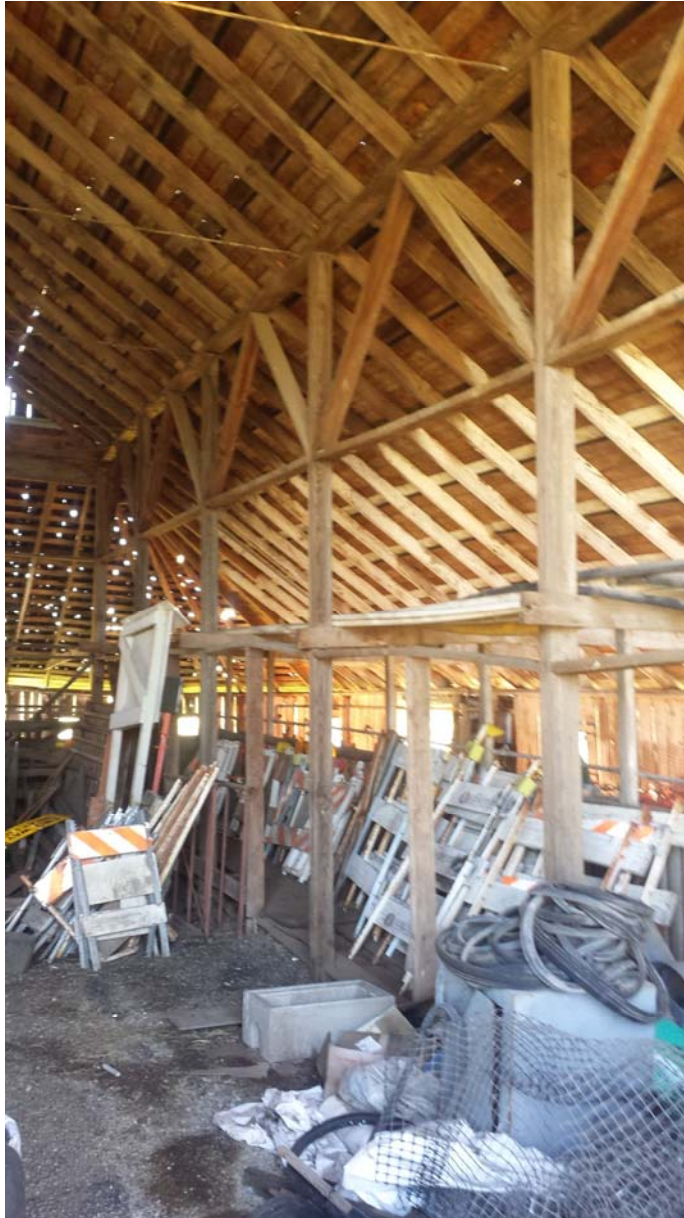
Figure 9 – Interior Dairy Barn posts bearing on soil

Occupancy less than 2,000 cumulative man-hours per year (tours, exhibits, etc.) – Provide a modern concrete foundation system to support the re-built round-nosed portion of the structure. This is included in the Seismic Remediation section above. Additionally, concrete pad footings will be required below the posts. These pad footings have been included in the Wall Bracing section above.

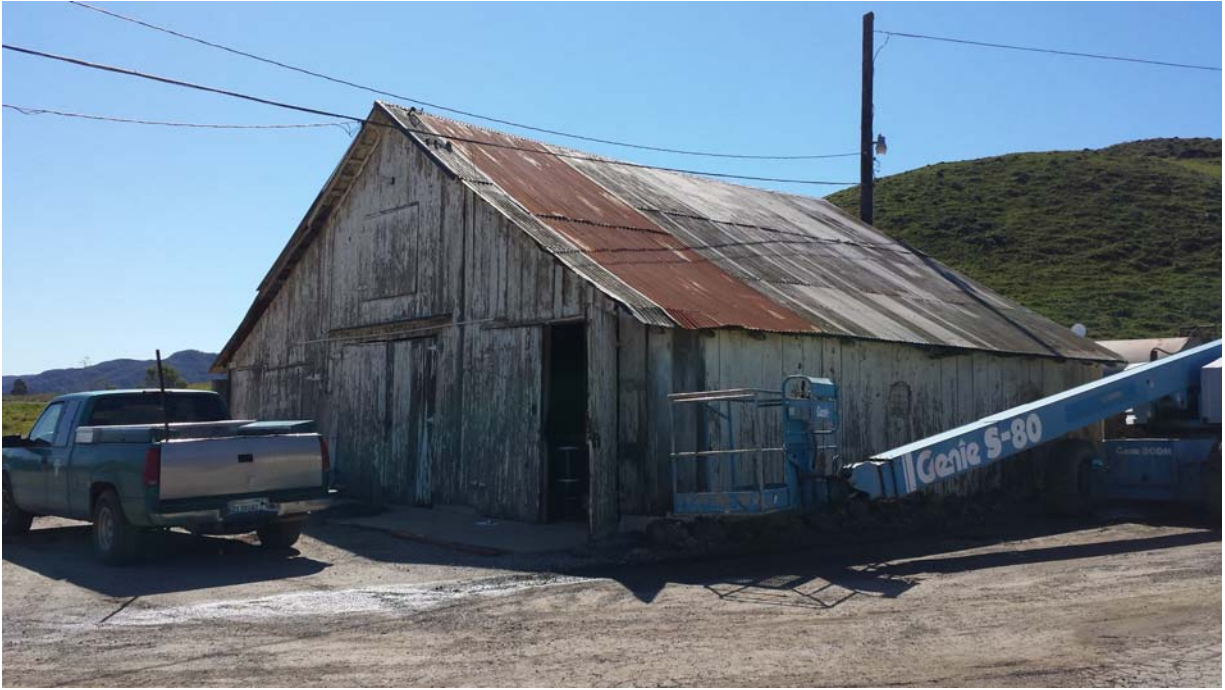
Figure 10 – Old Barn

The old barn [Figure 10] is an approximately 1,300 SF wood structure with a corrugated metal roof, vertical wood siding, and a concrete slab-on-grade foundation. It is estimated that the barn is 125 year old, and has been moved from its original site. The barn appears to be in very good shape for its age due to the fact that it remains in use. However, its constant use has led to a number of undocumented alterations that have inadvertently compromised the historic fabric of the Old Barn significantly.

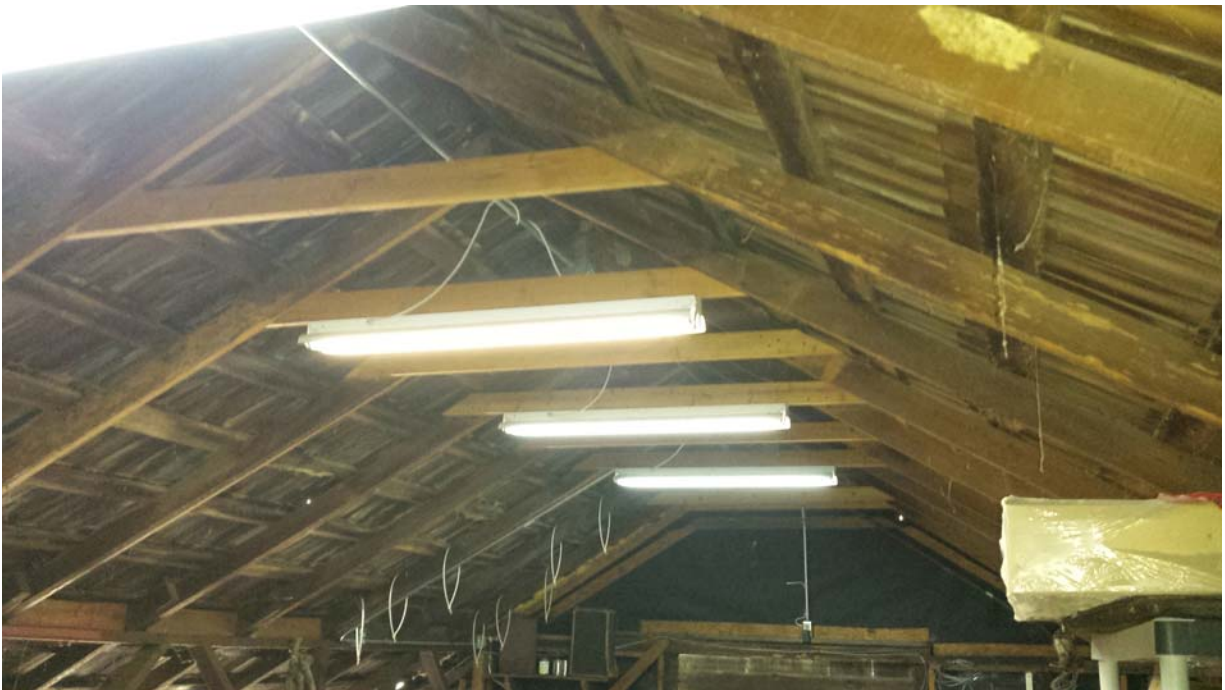
The existing roof framing [Figure 11] consists of corrugated metal roofing over existing wood shingles, over 1x6 skip sheathing, supported by 2"x4" roof joists at 32" spacing. A collar tie system consisting of 2x4 struts near the ridge is present to resist the horizontal thrust. This appears to have been added at a later date, most likely to combat a sagging ridge. The majority of the roof framing has the capacity to resist code-level dead and live loads. The existing skip sheathing provides minimal lateral stiffness lateral stiffness, and will not act as a proper roof diaphragm.

Figure 11 – Old Barn roof framing

Continued Private Commercial Use – If the structure will continue to be used for private commercial purposes, the building code does not require any upgrades to the roof framing system. It is recommended, however that the next time the roof is replaced, the original wood shakes be removed, and a layer of plywood added over the existing 1x skip sheathing. The layer of plywood, if detailed and nailed properly, will act as a structural diaphragm. Additional wood blocking and metal framing clips will also be required to tie the roof diaphragm to the exterior walls below. It should also be noted that if a new roofing material is selected that is heavier than the existing roofing material, strengthen of the roof rafters may be required.

For Use as Public Space – If the structure is to be used for public occupancy, the existing roofing shall be removed and the plywood, blocking and framing clips added as described above.

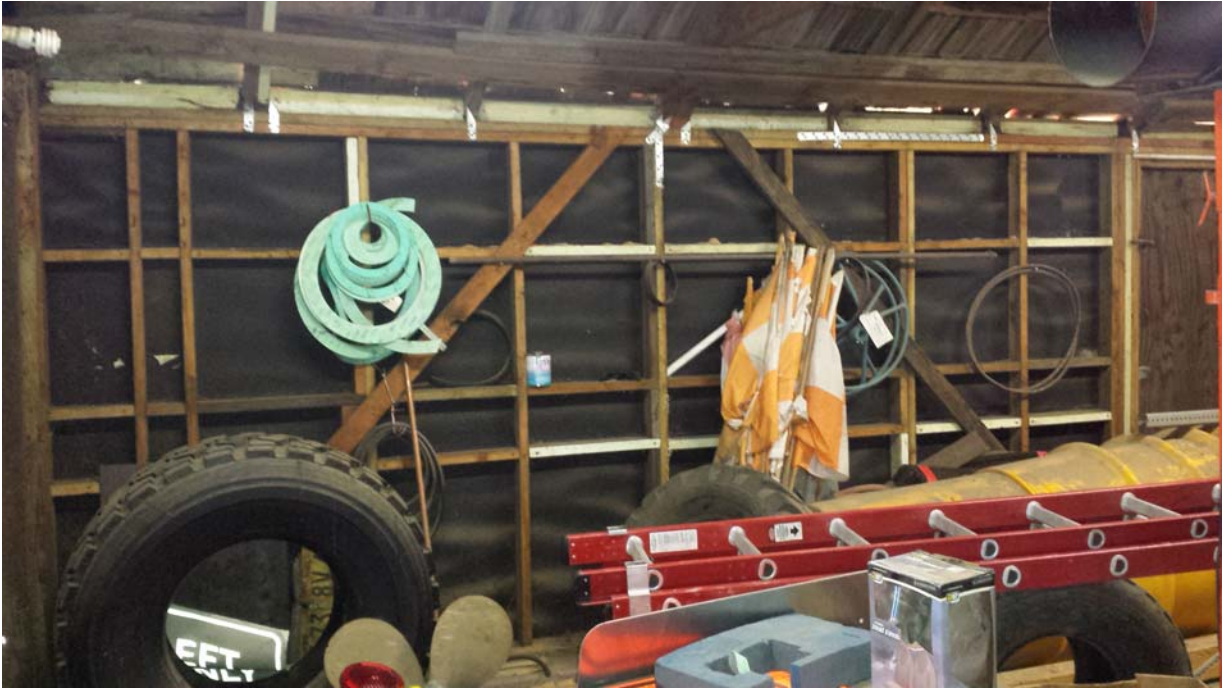
At some point in the history of the barn, the exterior walls were reframed with a more modern system of 2x4 vertical studs spaced at 16" o.c. [Figure 12]. This system likely replaced a post-and-beam system with horizontal wall girts, similar to the Dairy Barn described above. Blocking between the vertical studs is used to support the 1x12 vertical siding.

Figure 12 – Old Barn exterior wall framing

Continued Private Commercial Use – If the structure will continue to be used for private commercial purposes, the building code does not require any upgrades to the existing exterior walls. However, because of the three large door openings at the north elevation of the structure, a wood bracing system is recommended along this line.

For Use as Public Space – Same as above. Additionally, the exterior vertical siding is required to be in good condition to allow for adequate nailing. Proper nailing is essential for shear wall performance. It is estimated that up to 50% of the wood siding will need to be removed and replaced for the wood shear wall system. It is also estimated that approximately 5% of the wall framing will require replacement due to weather intrusion at the damaged siding. The entire exterior will require re-painting to help preserve the condition of the wood

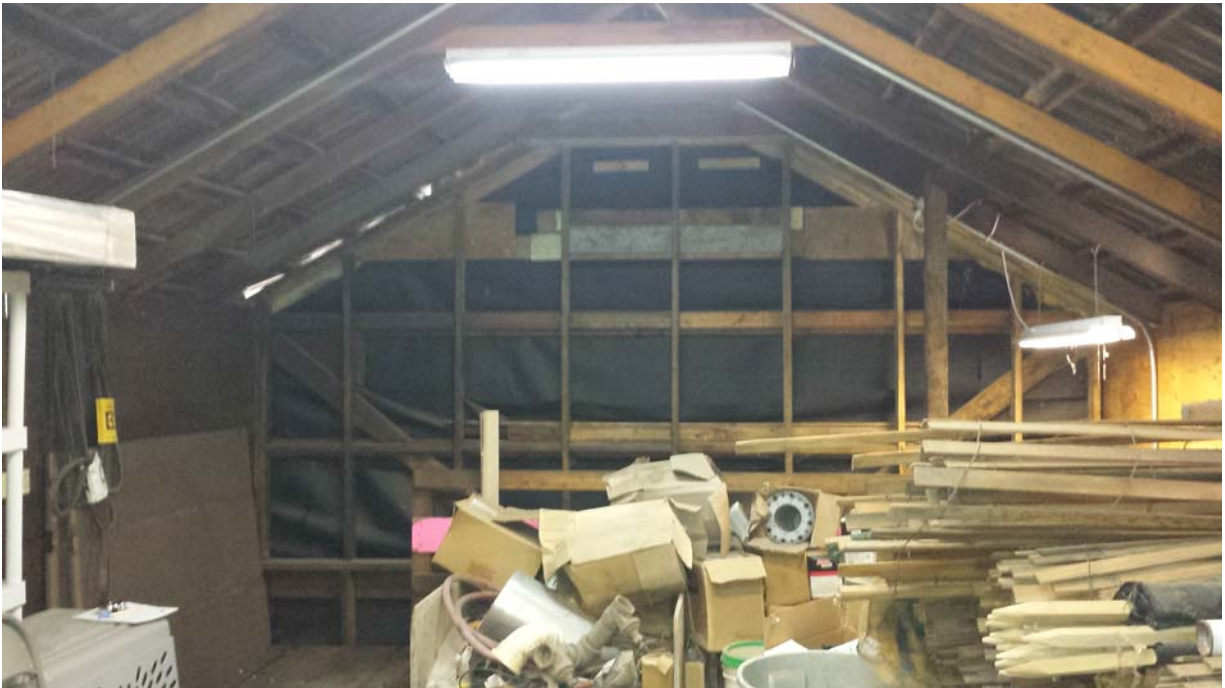
At each of the two interior lines of posts, a shear wall has been added [Figure 13]. It is unclear as to when and why the shear walls were added, however they do provide a significant amount of stiffness to the structure.

Figure 13 – Full-height plywood shear wall (left & right of photo)

Continued Private Commercial Use – If the structure will continue to be used for private commercial purposes, the building code does not require any upgrades to the existing exterior walls. However, if a plywood roof diaphragm is added at a later date, proper blocking and shear transfer detailing will be required.

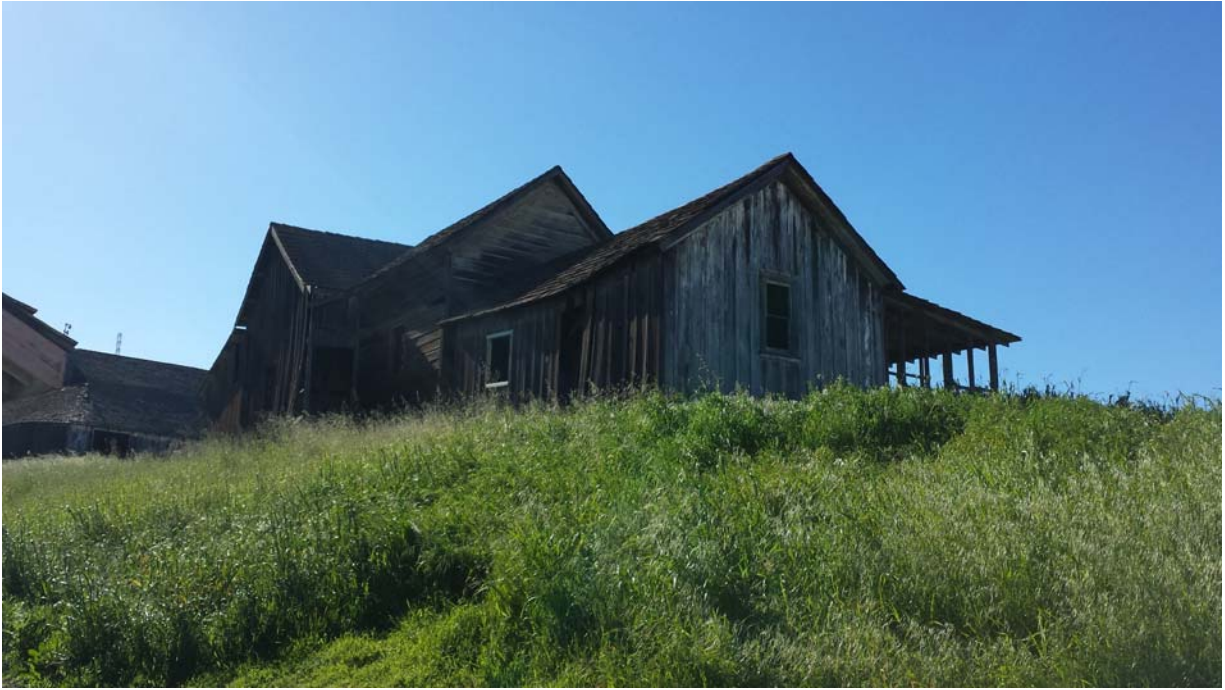
Figure 14 – Creamery House

The Creamery House [Figure 14] is an existing wood-framed structure in a state of disrepair. Years of abandonment have made it unfeasible for renovation [Figures 15 through 18]. Among the issues are the following:

The Creamery House is an unsafe building in a state of disrepair, and the materials are unsalvageable for structure purposes. It is recommended that the structure be properly documented and demolished.

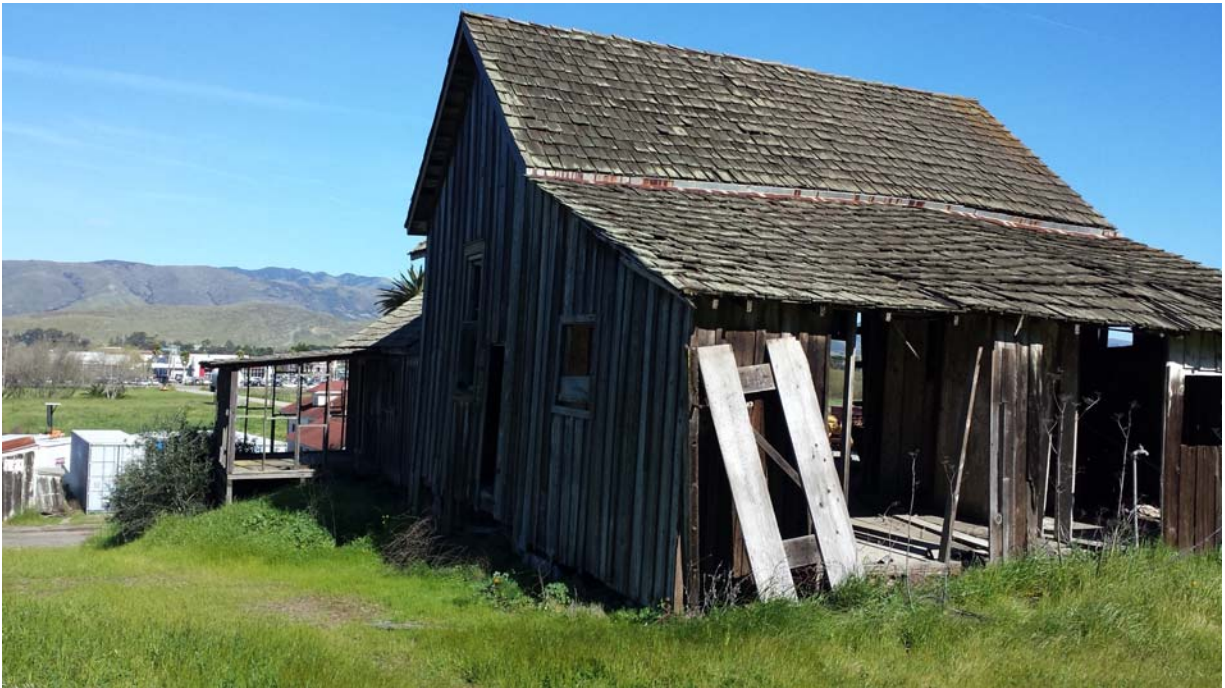
- All exterior siding requires replacement
- There are no wood studs in the majority of the walls. The siding, which has no bearing capacity, is currently supporting the majority of the roof loads.
- The roof framing is undersized and severely damaged.
- The floor framing is undersized and severely damaged.
- The wood post-and-beam foundation system is supported on rocks or soil and has failed.

Figure 15 – Deterioration of Creamery House

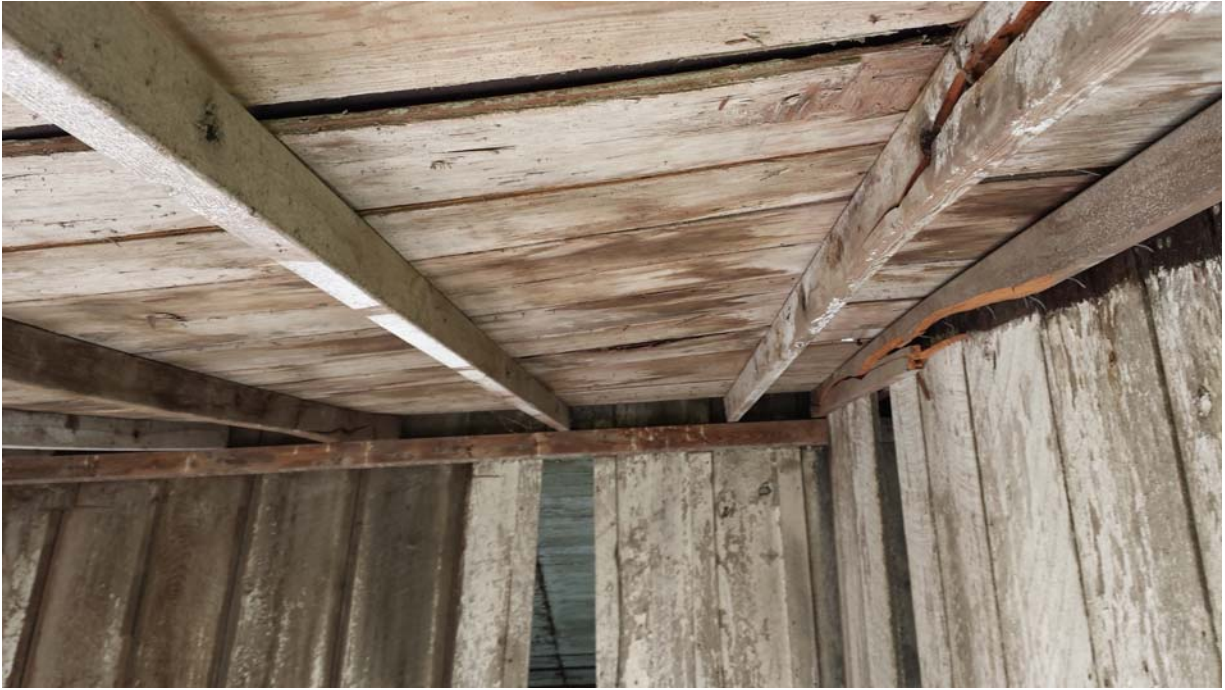
Figure 16 – Deterioration of Creamery House

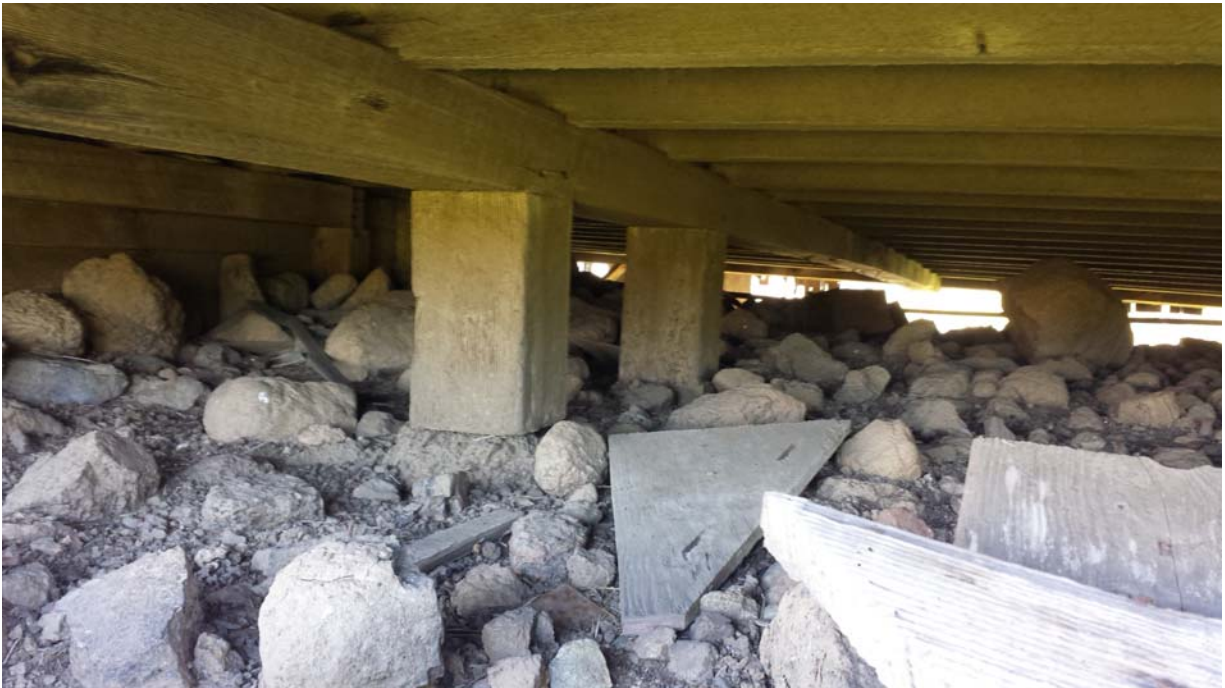
Figure 17 – Creamery House foundation

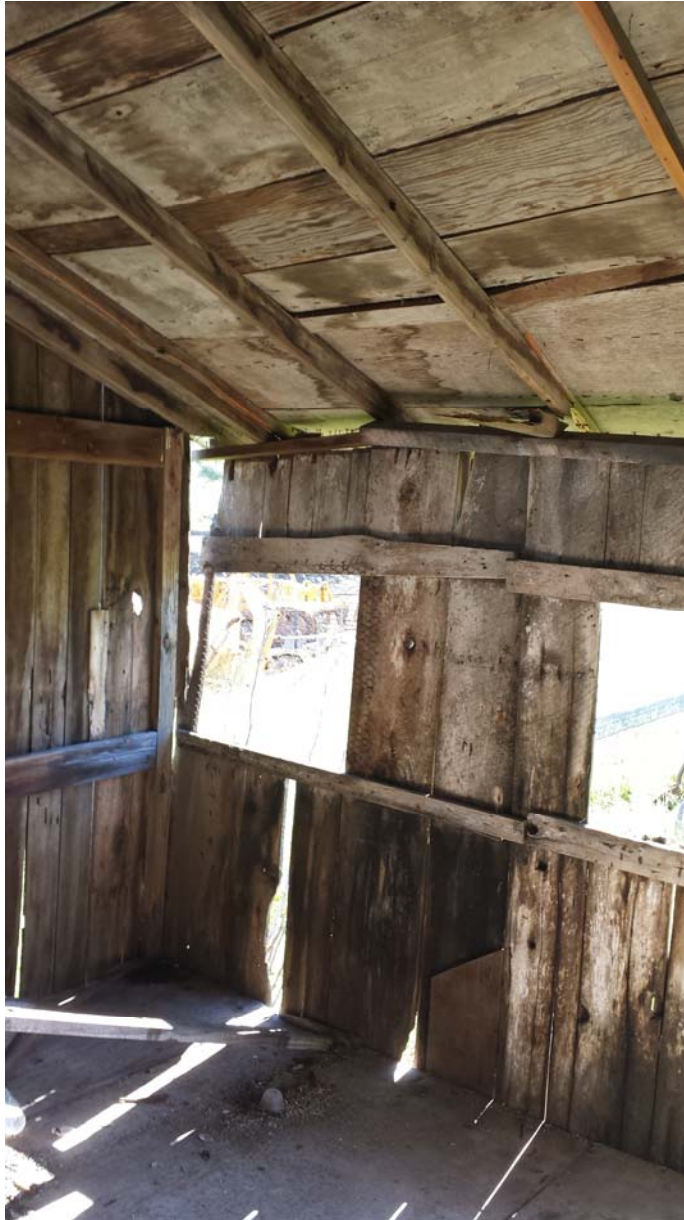
Figure 18 – Deterioration of Creamery House
