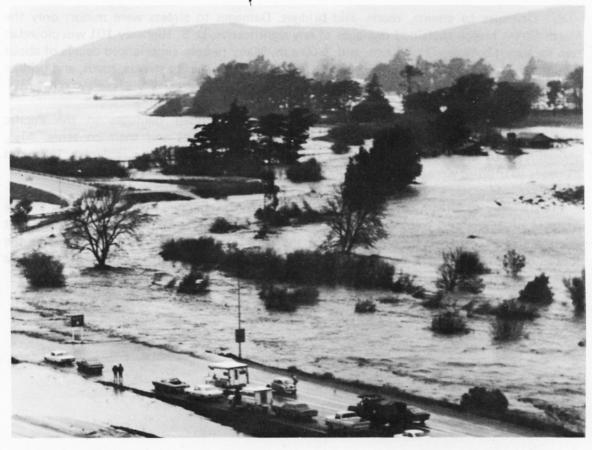
U.S. Highway 101 becomes impassable near the confluence of San Luis Obispo Creek and Prefumo Creek.

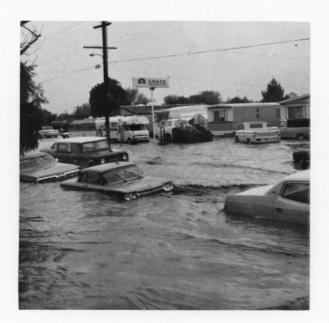
Motorists abandoned vehicles along Higuera Street.

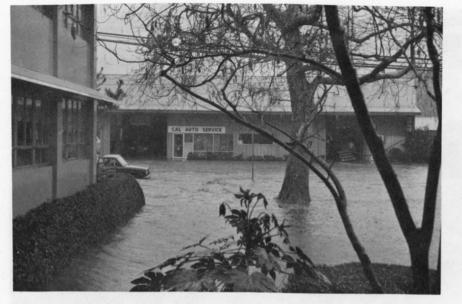
Floodwaters along Higuera Street, damaged commercial establishments.

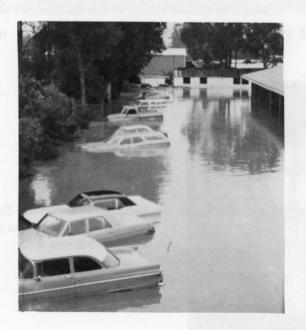
Vehicles in the Division of Highways parking lot are submerged by floodwaters.

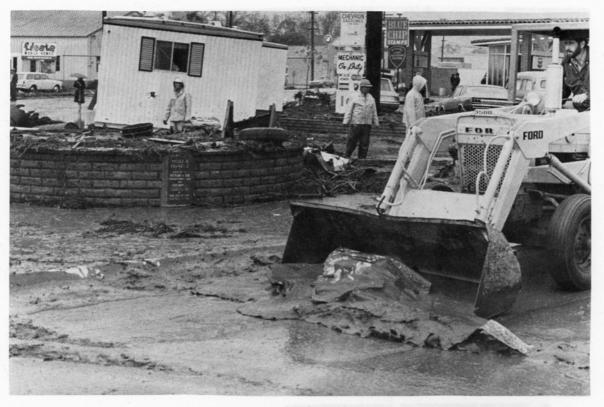
Cleanup operations by the city and volunteers commenced immediately after the storm.

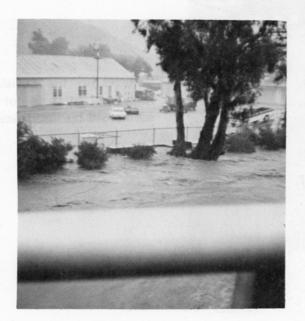
Floodwaters overtop San Luis Obispo Creek downstream from Madonna Road bridge.

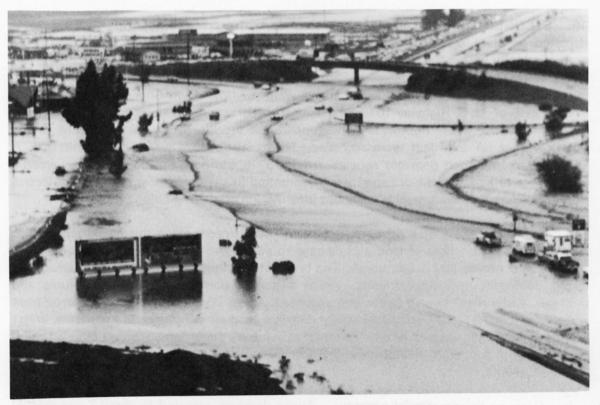
U.S. Highway 101 became impassable to motorists.

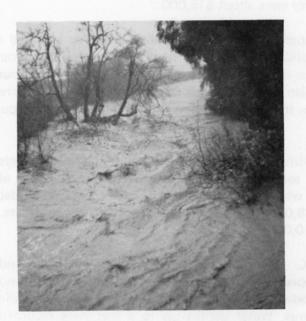
Trees and brush were uprooted by the erosive velocity of floodwaters within the creek.

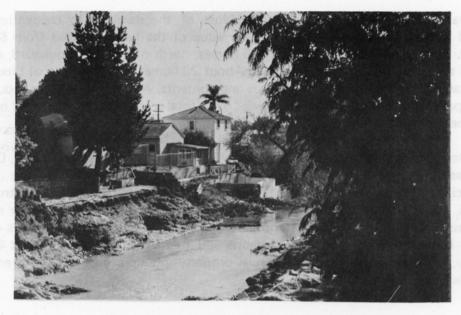
Erosion of land and damaged patios along Stenner Creek.

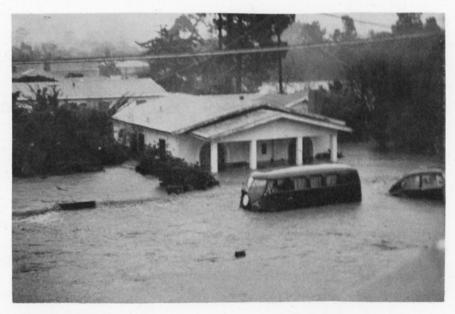
Floodwaters inundated this house on Broad Street and Lincoln Avenue.

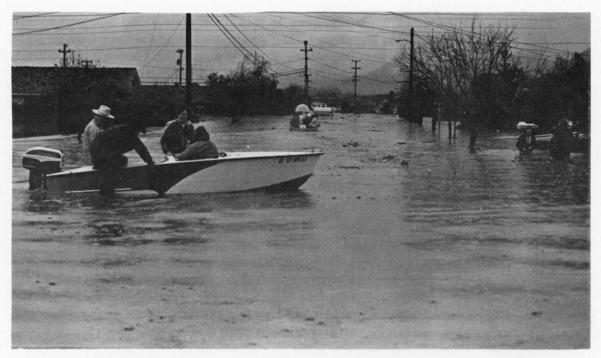
Residents in the Laguna Lake area resort to motorboats as a means of transportation.

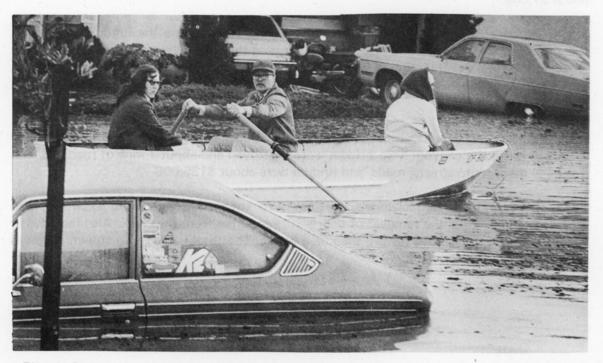
Flood victims take to the rowboat along Oceanaire Drive as floodwaters 3 feet deep inundated the Laguna Lake area.

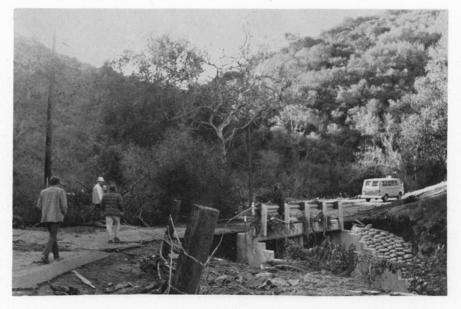
Bridge crossing Prefumo Creek indicates results of damages caused by floodwaters.

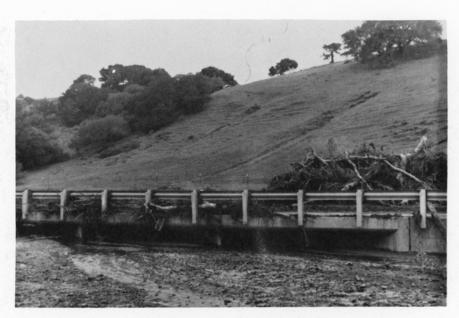
Silt deposit was a major problem along Prefumo Creek, as is evident from view of this bridge.

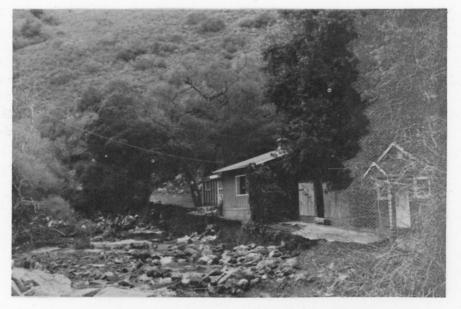
Erosion along Prefumo Creek caused damage to this property.

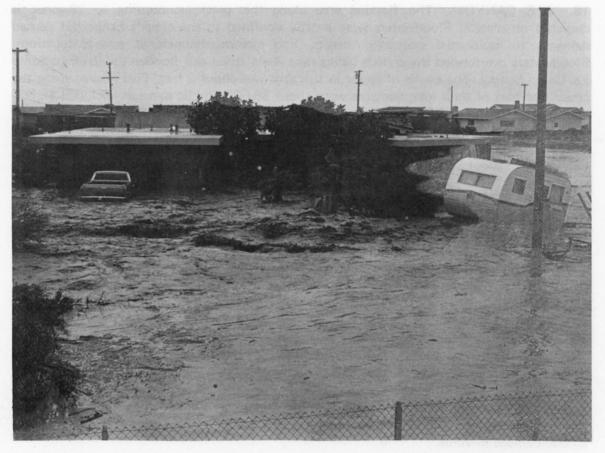
Floodwaters from an unnamed creek in the City of Morro Bay inundated this home west of State Highway 1.
