Air Quality and Greenhouse Gas Emissions Calculations and Modeling Results

RTA Maintenance Facility Project - San Luis Obispo County, Annual

# San Luis Obispo Regional Transit Authority Coordinated Transit Maintenance and Dispatch Facility Project

## Cultural Resources Survey Report

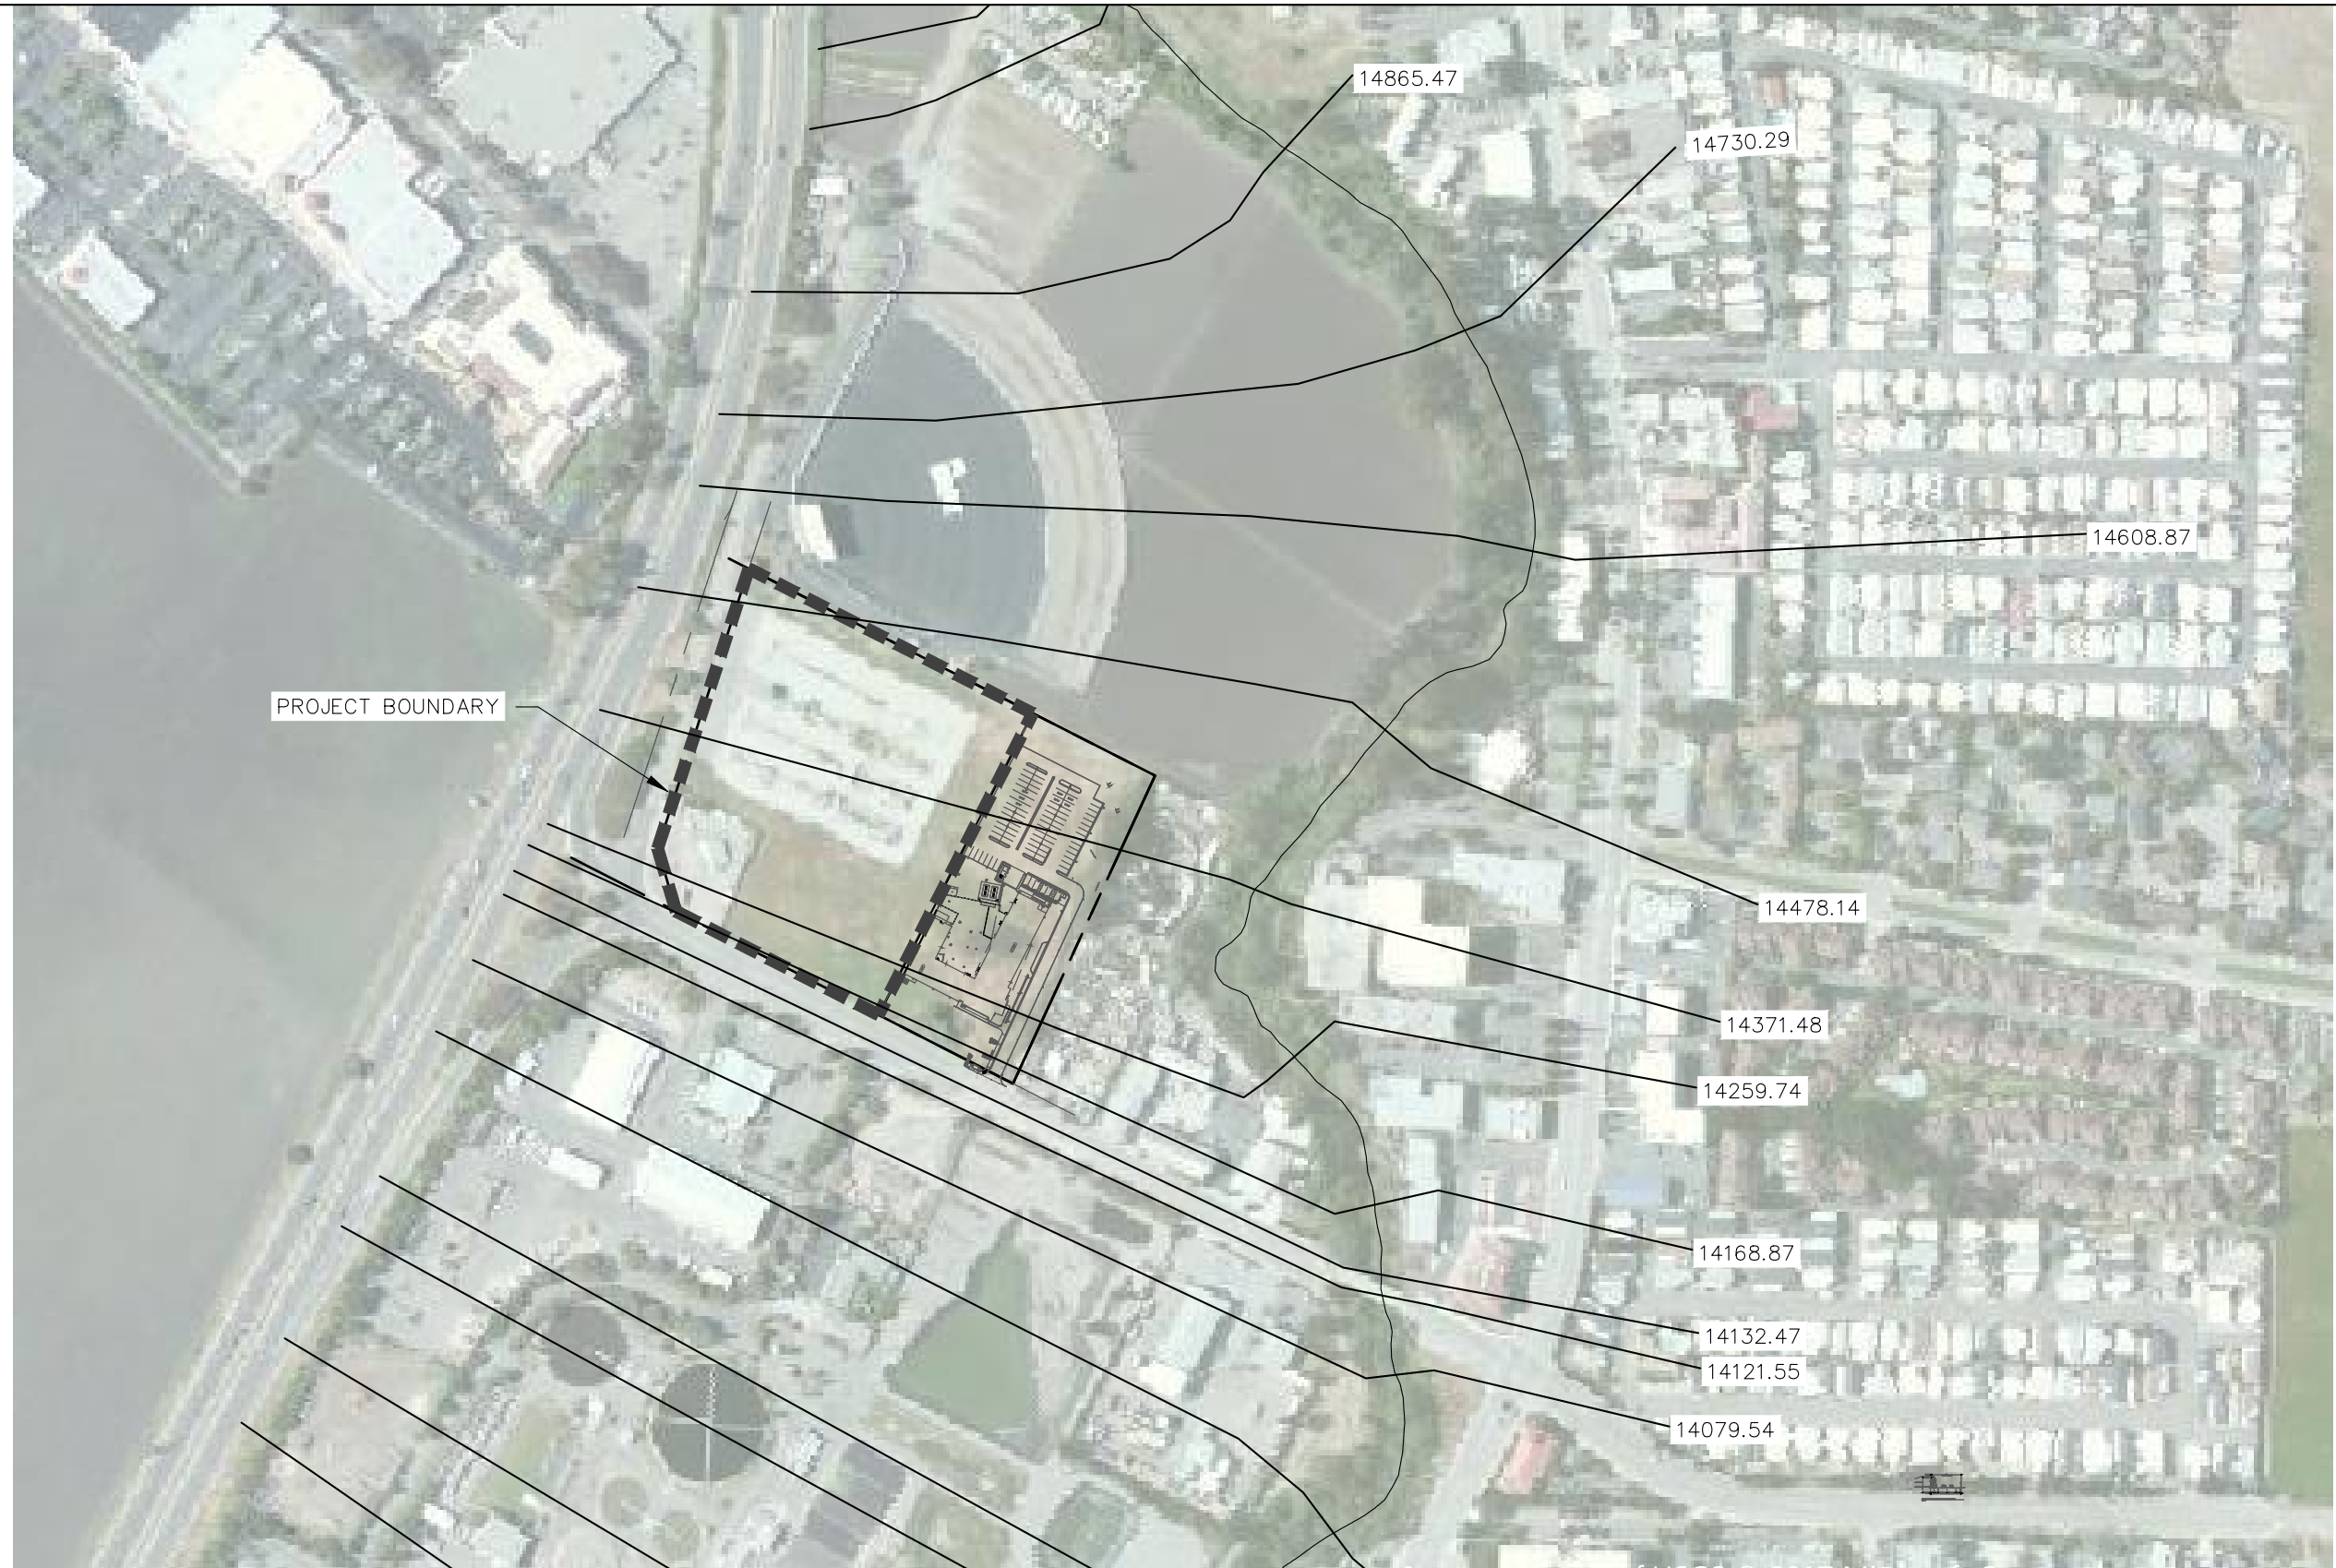
PROJECT BOUNDARY

1. Figure 1 – HEC-RAS Cross-sections Pre-project Conditions
2. Figure 2 – HEC-RAS Cross-sections Post-project Conditions
3. FEMA Flood Insurance Rate Map
4. Drainage Design Manual Figure DDM 1 – Special Floodplain Management Zones
5. Drainage Design Manual Figure DDM 3-2c – City’s 100-yr Floodplain
6. HEC-RAS Output for Pre-project Conditions
7. HEC-RAS Output for Post-project Conditions

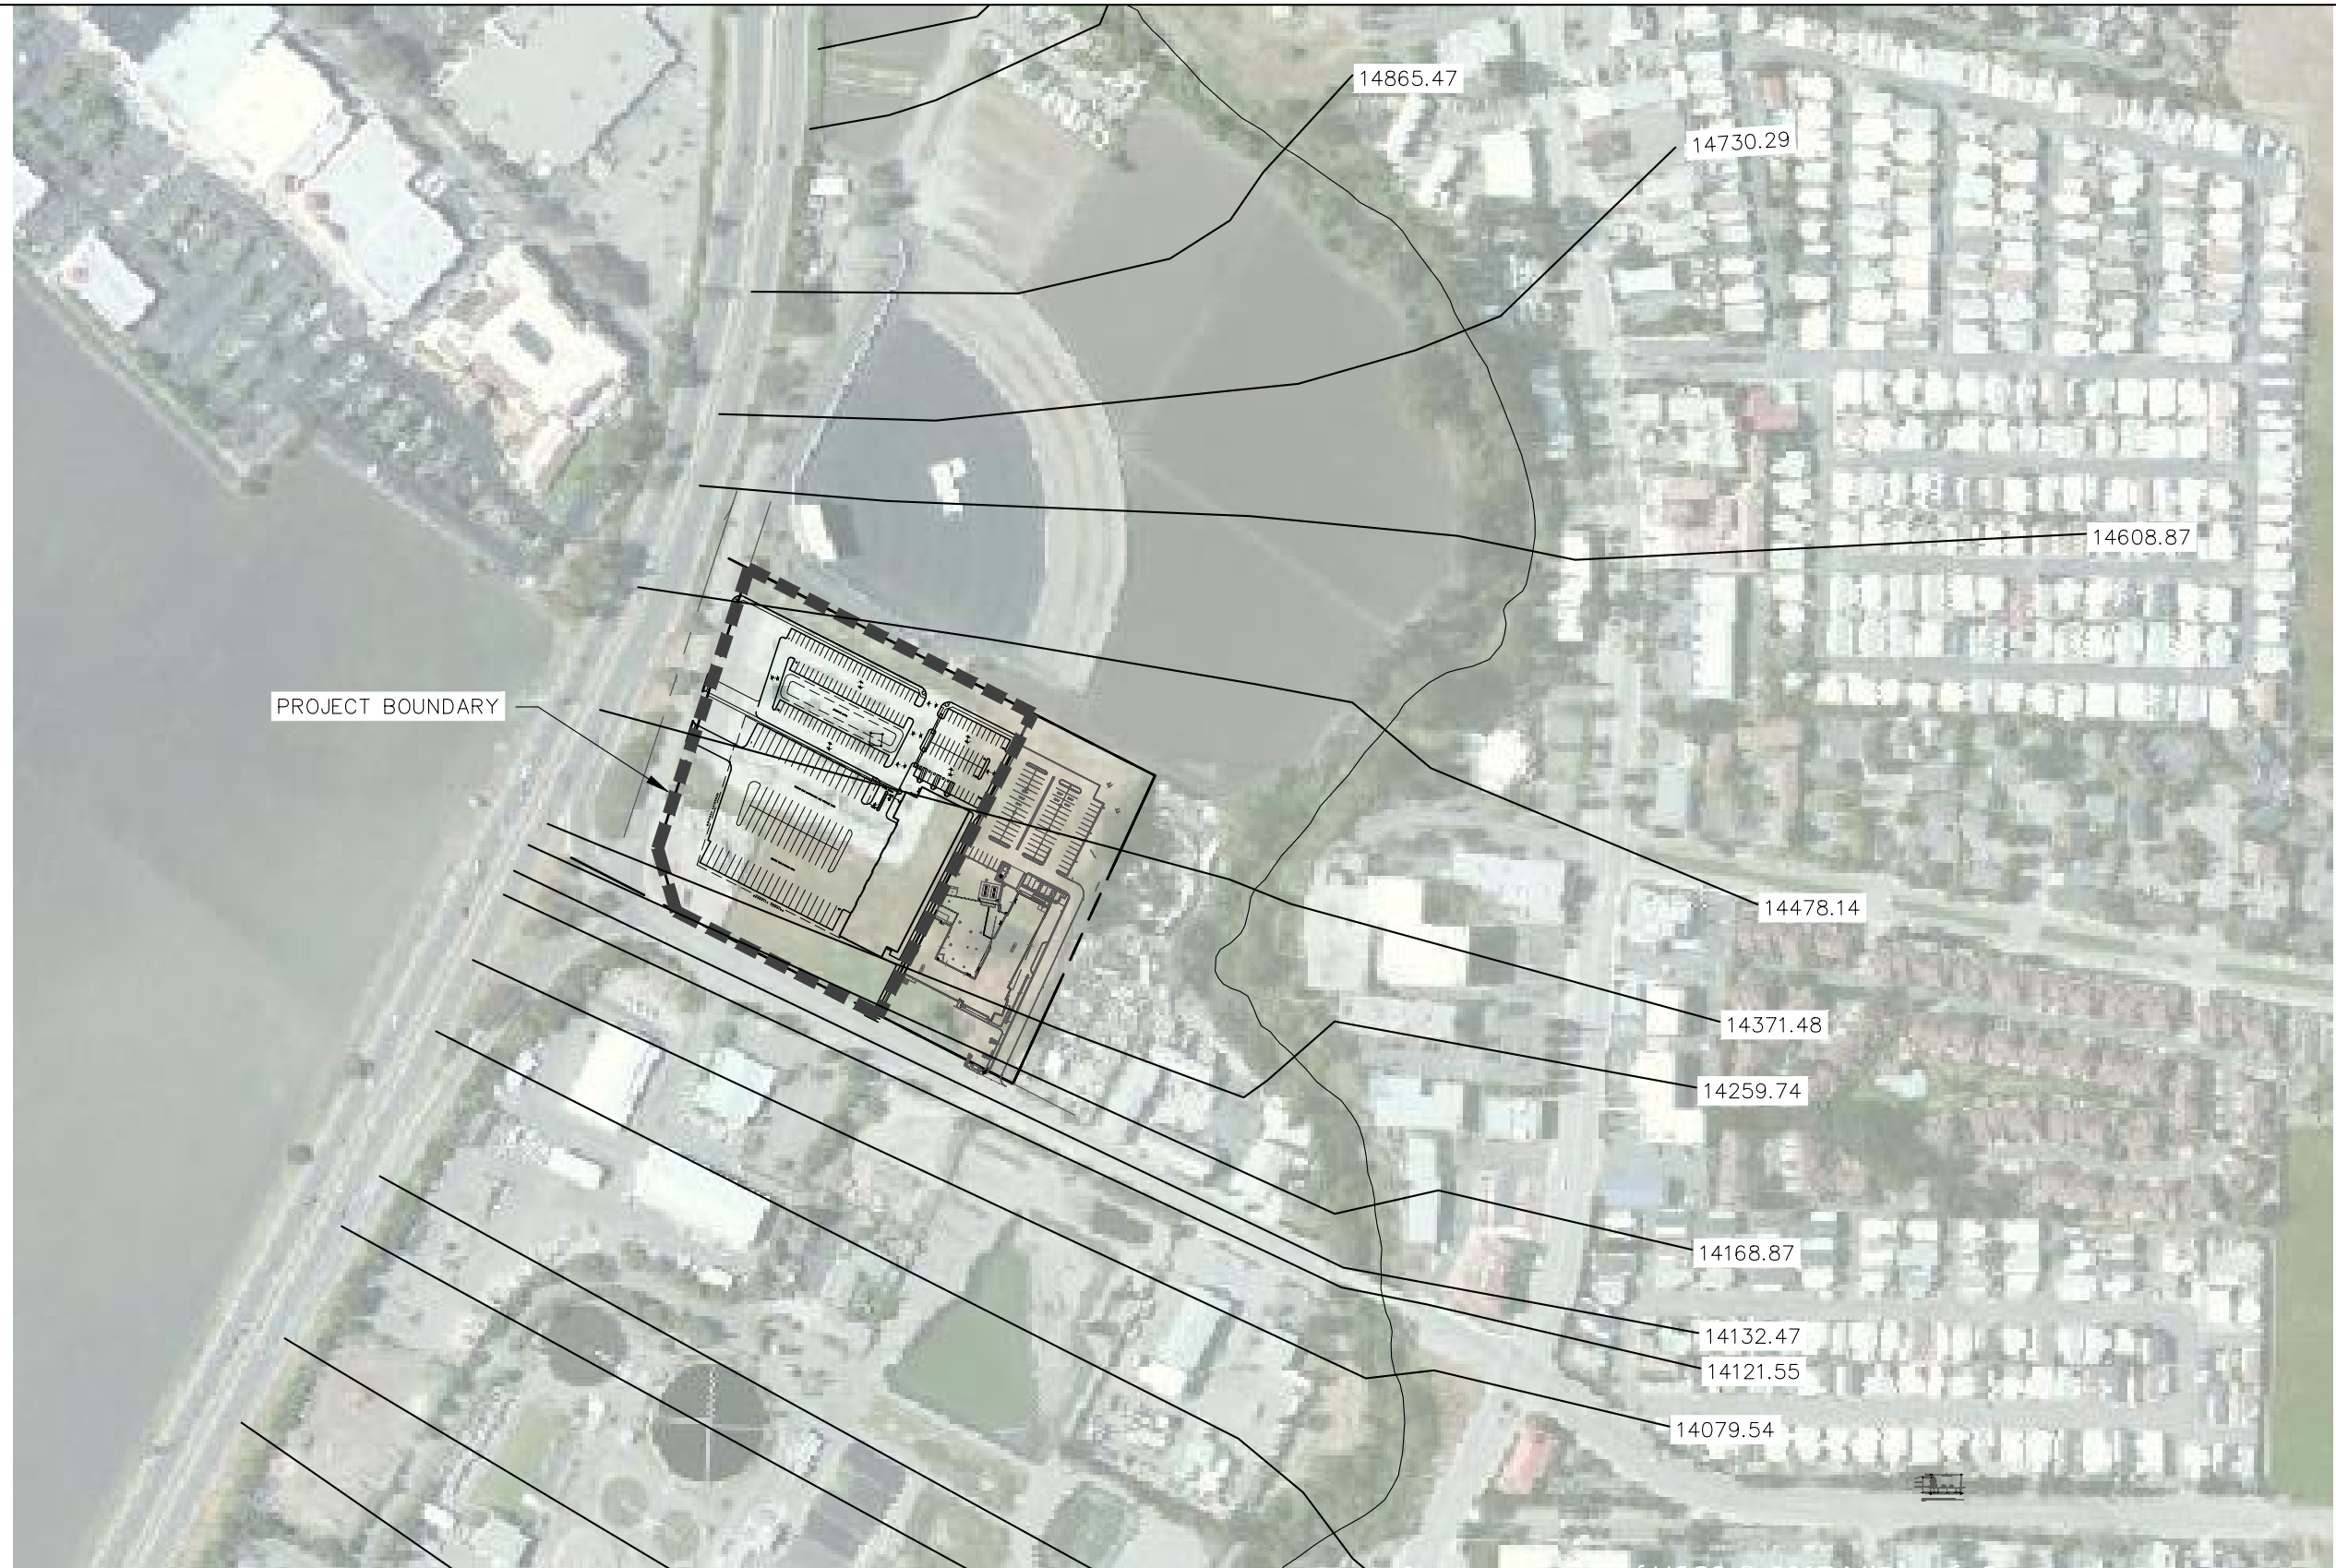
FIGURE 2

RTA MAINTENANCE FACILITY HEC-RAS CROSS-SECTIONS POST-PROJECT CONDITIONS SAN LUIS OBISPO, CA		
DRAWN BY STS	DATE 2/7/17	CA JOB NO. 150823
CHECKED BY	SCALE 1" = 300'	SHEET 1 OF 1

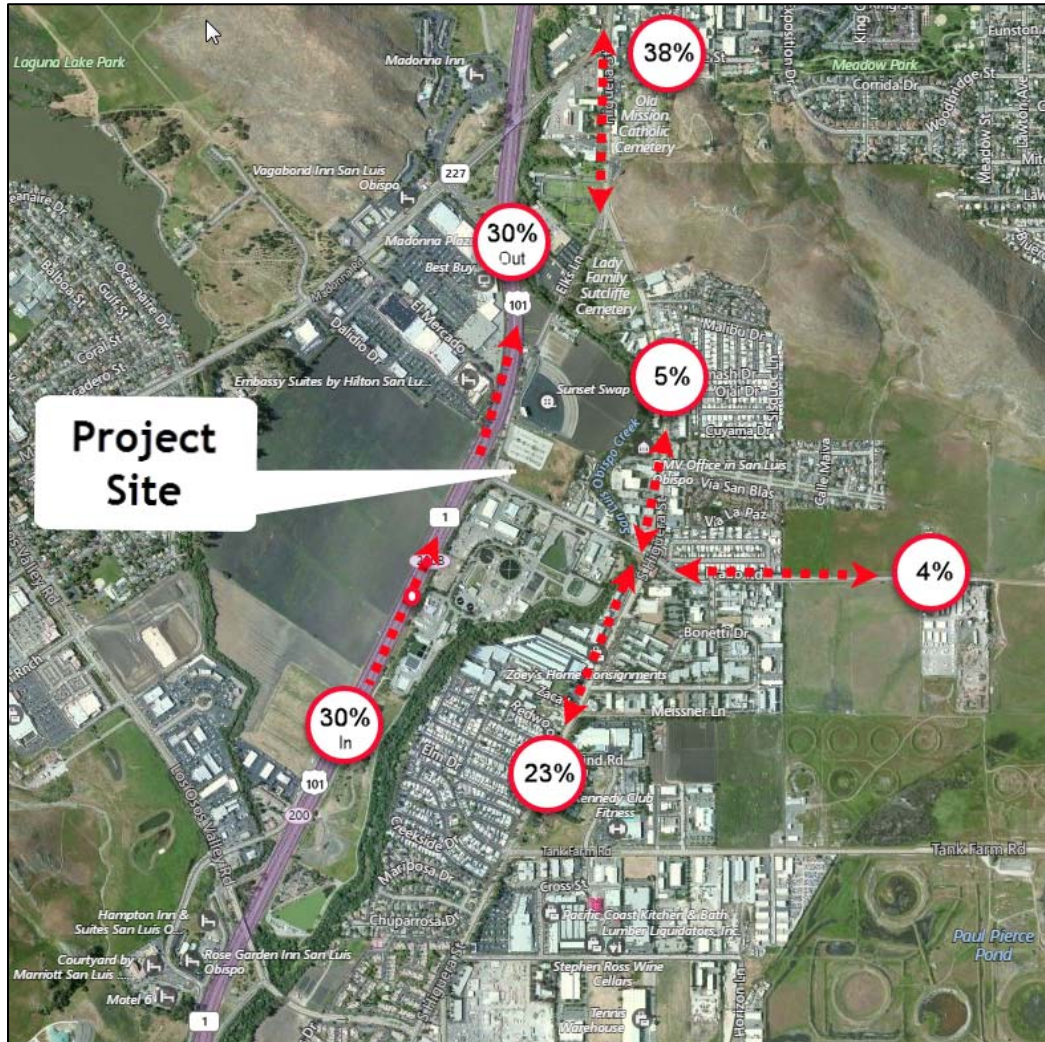
**FIGURE 5 –  
PROJECT TRIP DISTRIBUTION**

- 38% to/from Higuera Street n/o Elks Lane
- 30% to/from U.S. 101
- 5% to/from Higuera Street n/o Prado Road
- 23% to/from Higuera Street s/o Prado Road
- 4% to/from Prado Road e/o Higuera Street

The project is expected to “generate” and “attract” trips throughout the City and from other locations throughout the area. Directional trip distribution for project generated trips was estimated based upon use of the City of San Luis Obispo Citywide Travel Demand Model, existing traffic flow patterns, geographic location of the project sites, and location of other similar destinations. This resulted in a distribution of all project trips throughout the study area that is shown in Figure 5 and summarized below:

The *Existing plus Project* conditions were developed by superimposing proposed AM and PM peak hour project-generated trips (Table 5) using the proposed project trip distribution (Figure 5) onto existing traffic volumes (Figure 3). The resulting *Existing plus Project* traffic volumes are presented in Figure 7. Table 6 presents the results of the *Existing plus Project* conditions analysis.
