**WETLAND DELINEATION AND
JURISDICTIONAL DETERMINATION REPORT
FOR
862 AEROVISTA PLACE (APN 053-412-015)
SAN LUIS OBISPO, CALIFORNIA**

Terra Verde Environmental Consulting, LLC
3765 South Higuera Street, Suite 102
San Luis Obispo, CA 93401

Storrer Environmental Services, LLC
2565 Puesta Del Sol Road, Suite 203
Santa Barbara, California 93105

August 2019

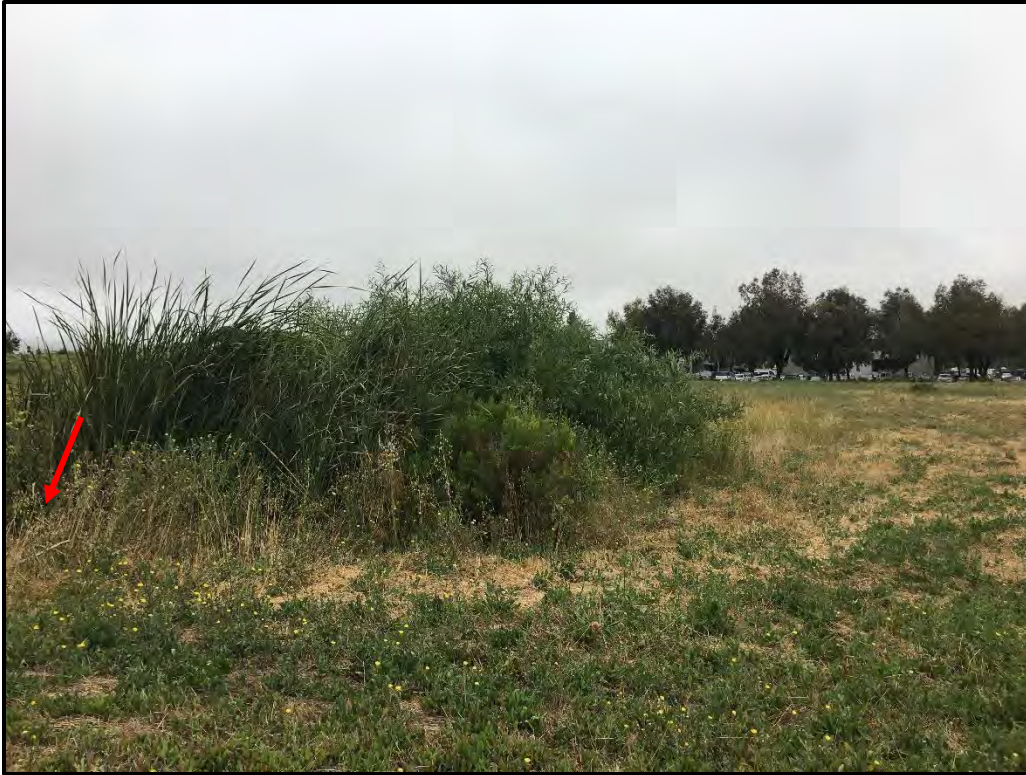
Photo 1. Cattail and arroyo willow stand at the outlet of the 36-inch culvert at Aerovista Place (Aspect: Northwest). Red arrow indicates culvert location.

At the outlet of the 36-inch culvert at Aerovista Place (SP-02), the unnamed tributary supports a stand of broad-leaf cattail (*Typha latifolia*; OBL) and arroyo willow (*Salix lasiolepis*; FACW) (Appendix A – Site Photographs). The remainder of the channel contains dense herbaceous vegetation dominated by tall flatsedge (*Cyperus eragrostis*; FACW), harding grass (*Phalaris aquatica*; FACU), common spikerush (*Eleocharis macrostachya*; FACW), brown-headed rush (*Juncus phaeocephalus*; FACW), and curly dock (*Rumex crispus*; FAC) (SP-01 and SP-03).

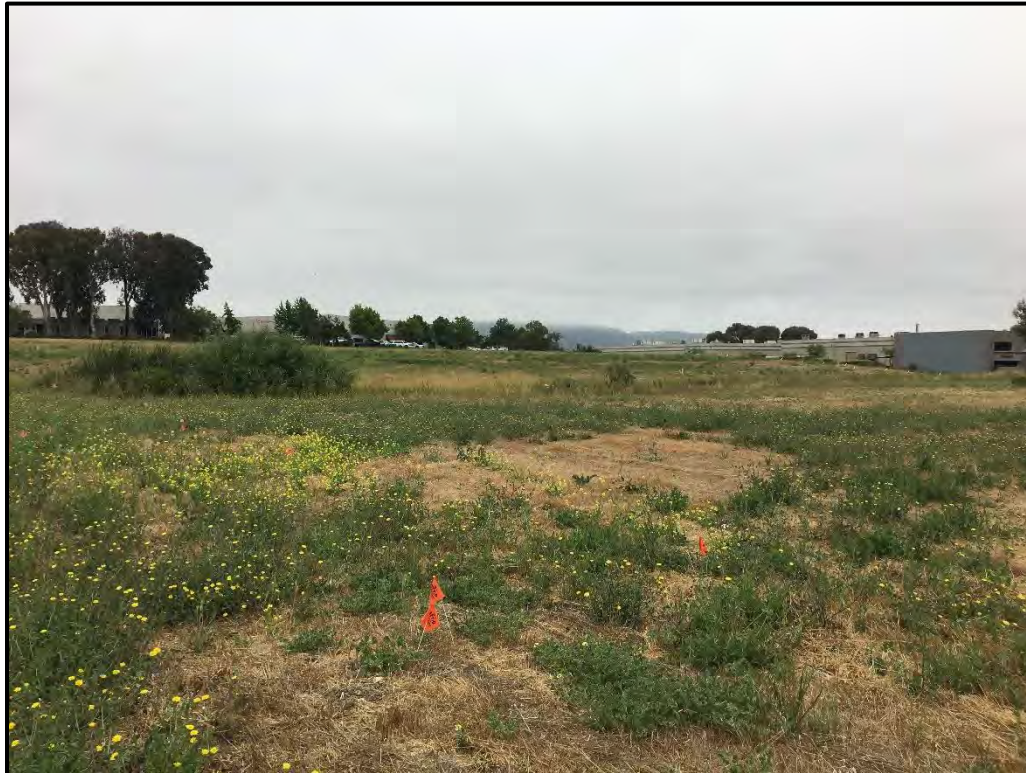
Photo 2. Upland habitat with cattail/willow stand and unnamed tributary in the background (Aspect: West). Upland area was recently mowed to the edges of the drainage.

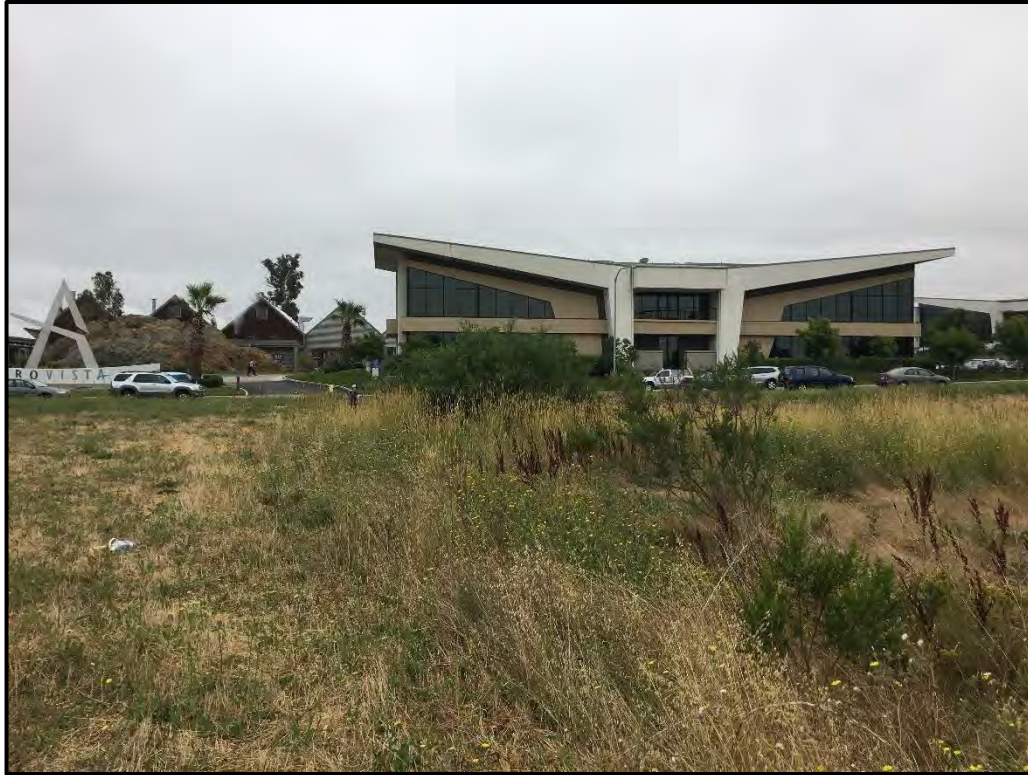
Photo 3. South end of the unnamed tributary looking toward Aerovista Place (Aspect: South).

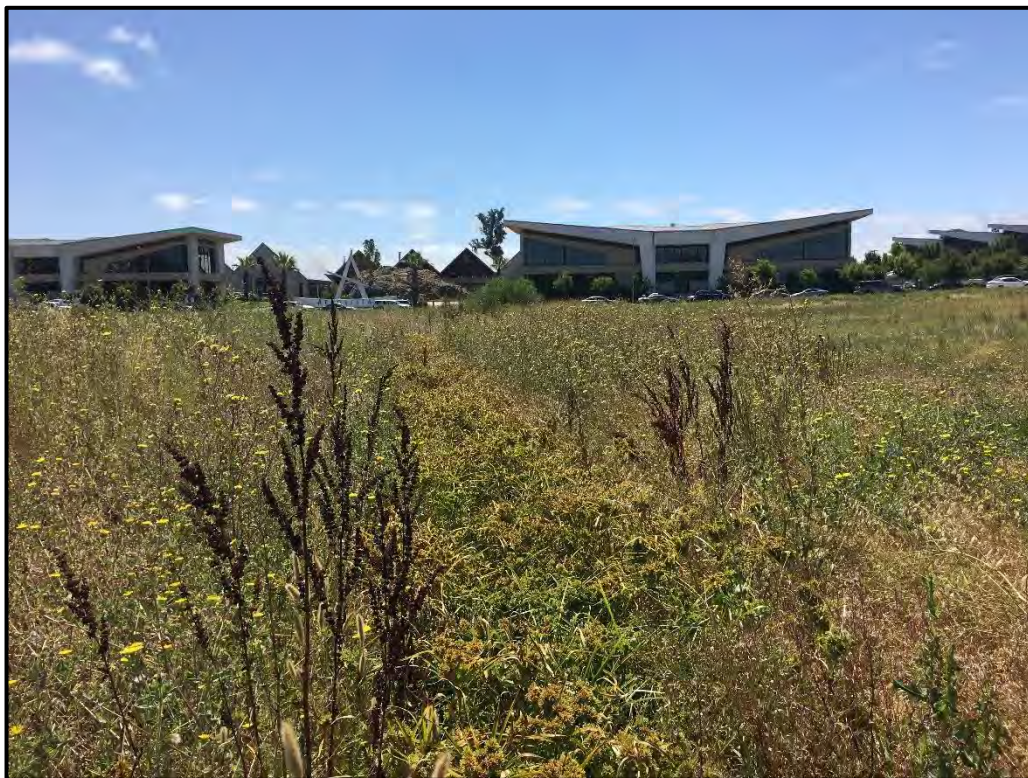
Photo 4. North end of unnamed tributary on adjacent parcel (Aspect: South). Channel is narrow and dominated by dense hydrophytic vegetation (tall flat sedge).

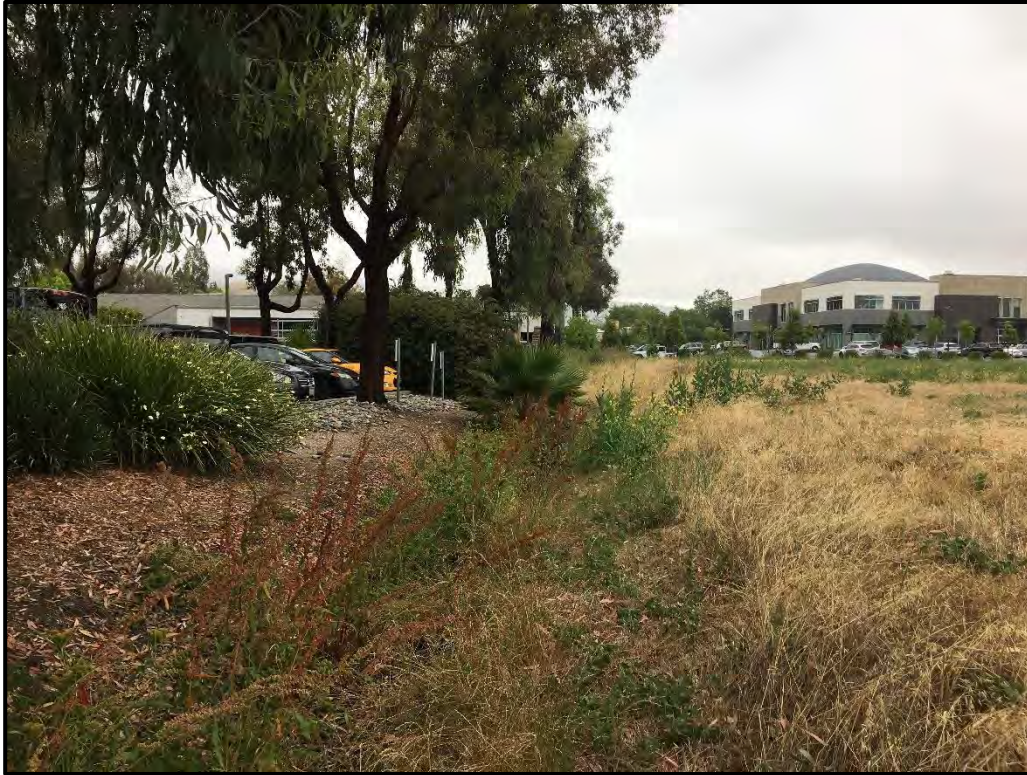
Photo 5. Unnamed tributary at the northern property boundary prior to entering the 48-inch box culvert (Aspect: East).

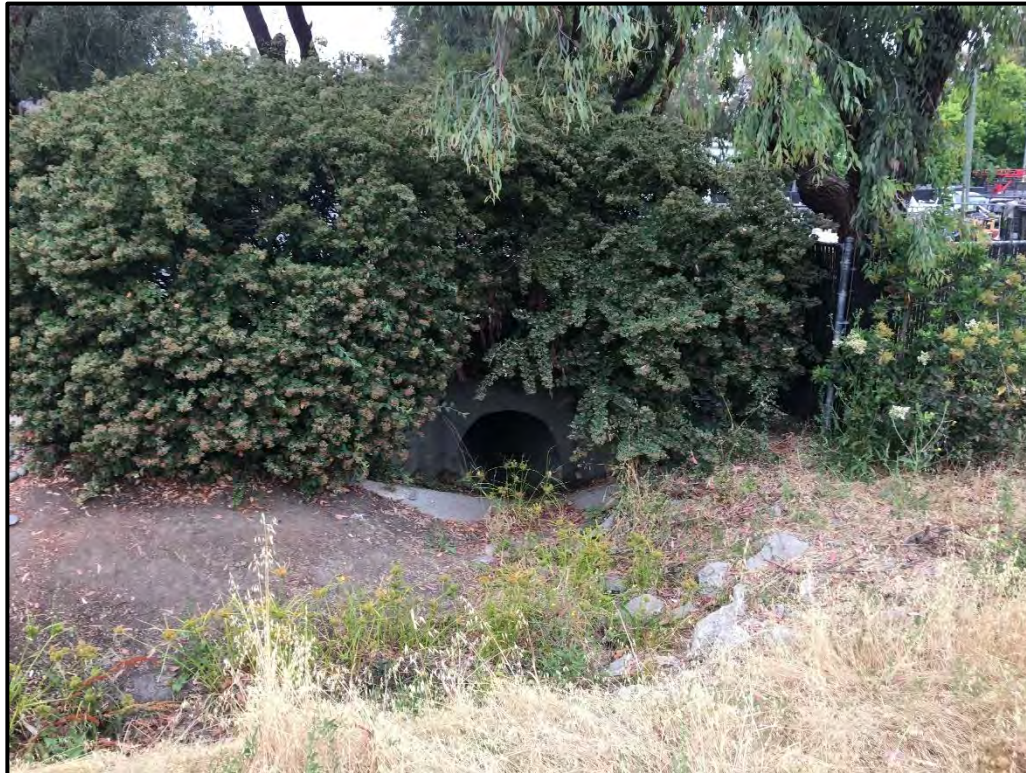
Photo 6. 48-inch box culvert that extends under Fiero Lane and outlets to Acacia Creek, (Aspect: North).

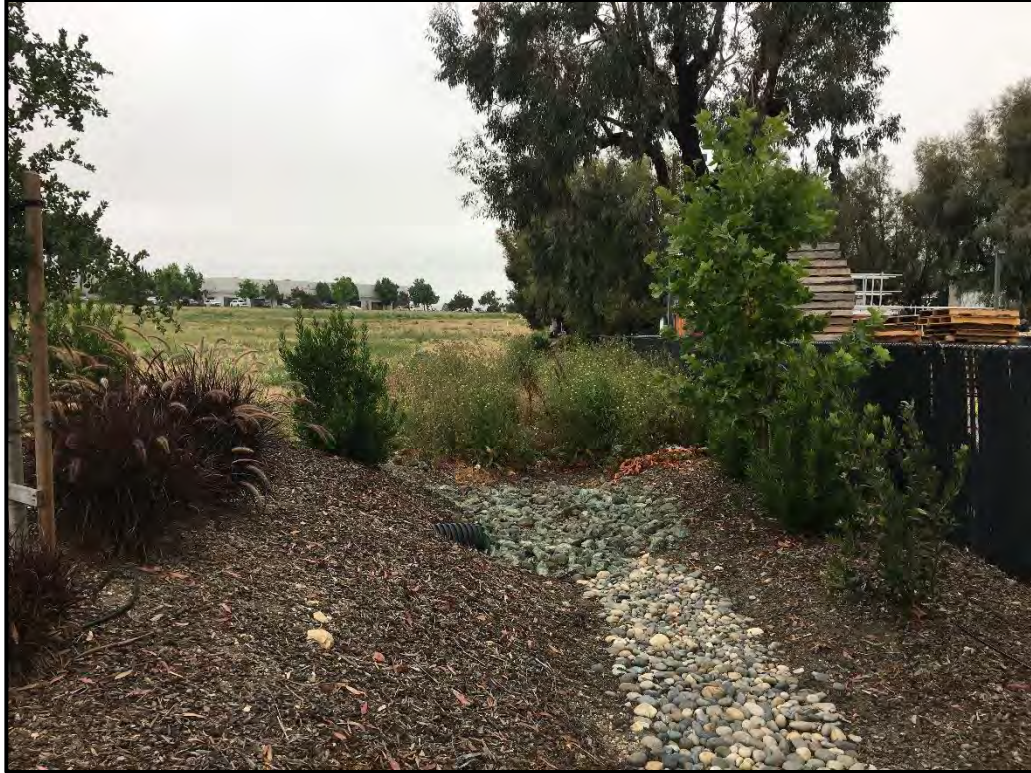
Photo 7. 12-inch culvert on the adjacent parcel at the northeast corner of the Survey Area (Aspect: West).

The unnamed tributary also receives runoff from the adjacent commercial property to the east. A 12-inch culvert outlets at the northeast corner of the Project Site to a shallow swale, which conveys runoff to the 48-inch concrete box culvert.

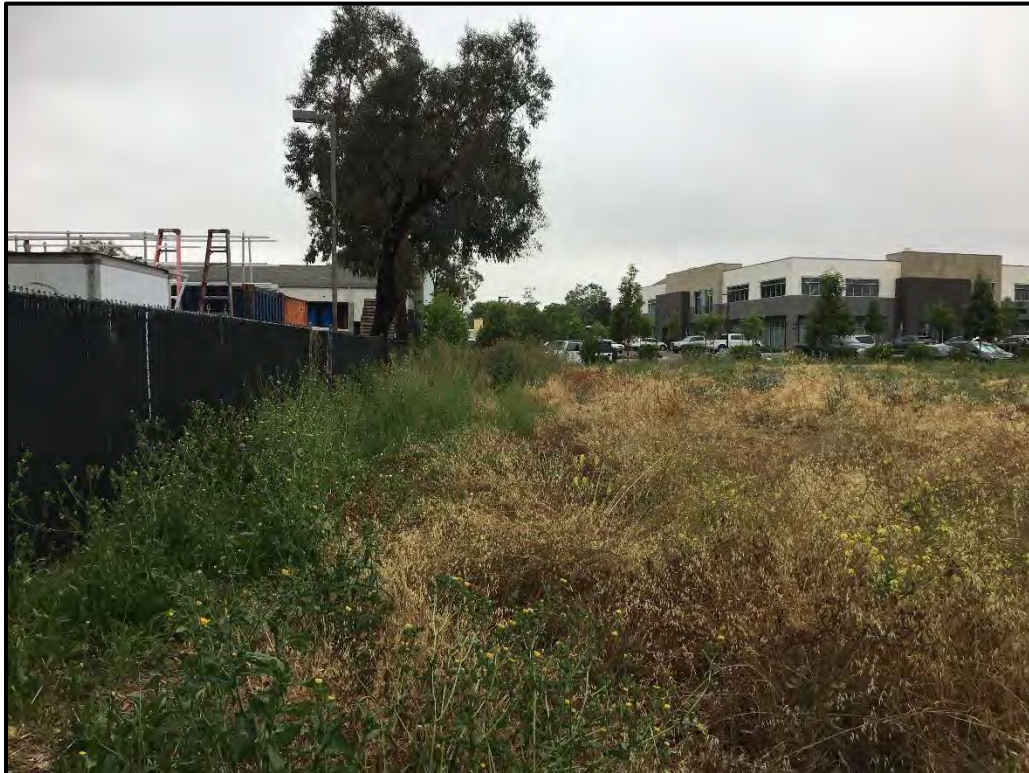
Photo 8. Densely vegetated swale that conveys flow from 12-inch culvert at the northeast corner of the Survey Area (Aspect: East).

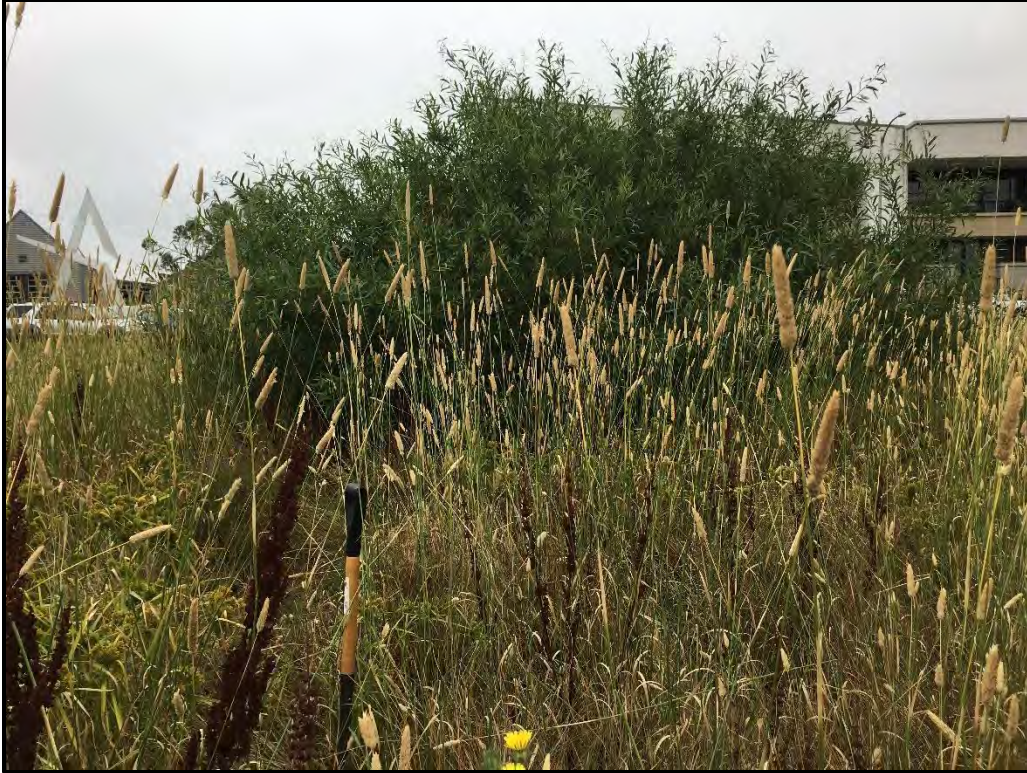
Photo 9. Sampling point (SP-01) downstream of cattail/willow stand (Aspect: South).

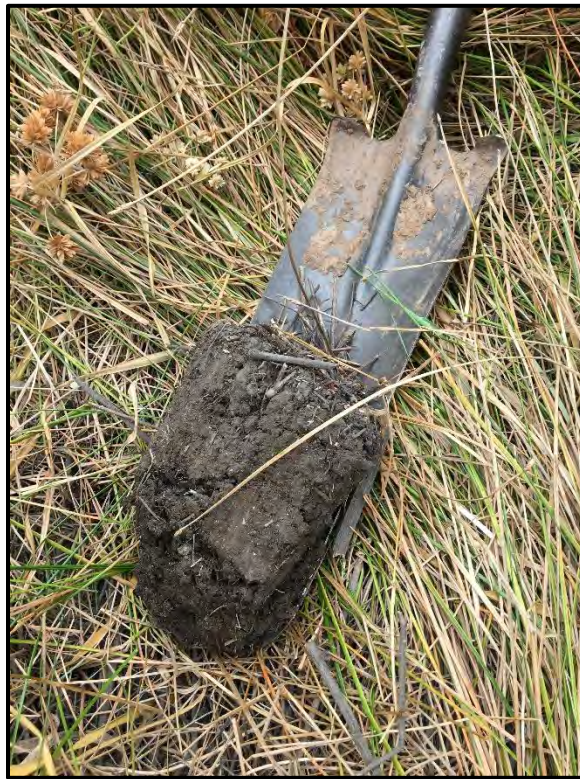
Photo 10. Soil profile at SP-01. No hydric soil indicators observed.

Remarks: redox concentrations present but faint/few; no hydric soil indicators observed (less than 2%)

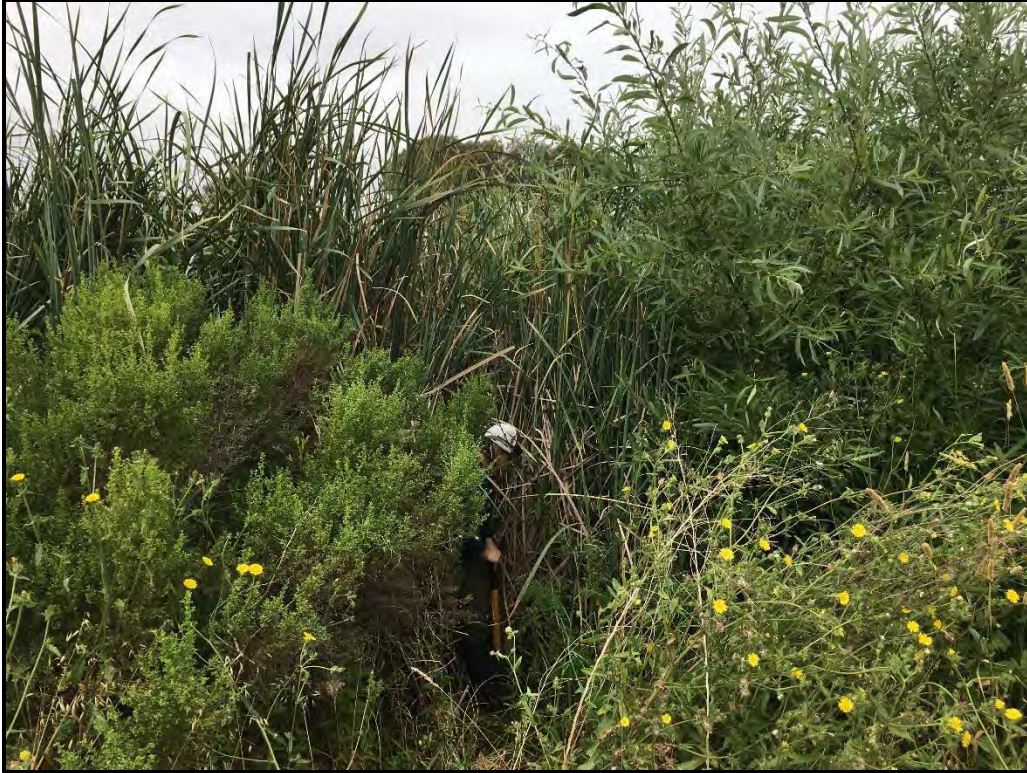
Photo 11. Sampling point (SP-02) within cattail/willow stand at the outlet of the 36-inch culvert at Aerovista Place (Aspect: West).

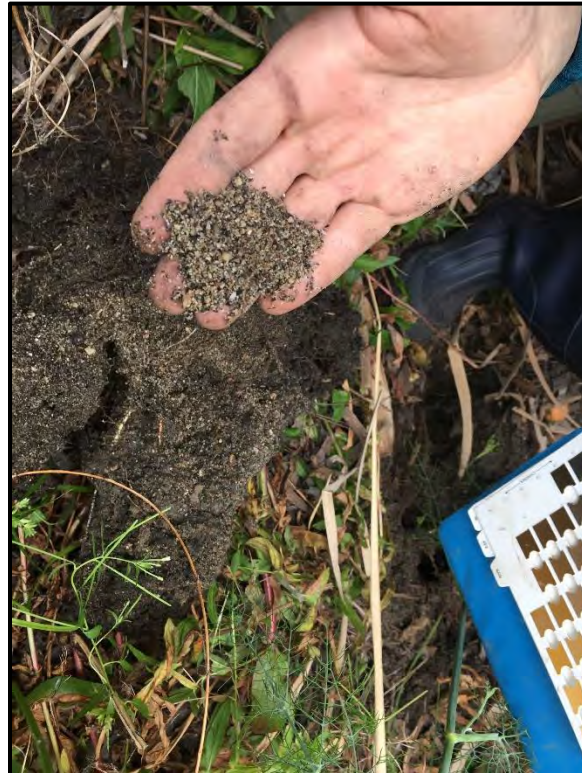
Photo 12. Coarse sand soil in SP-02 soil profile. No hydric soil indicators observed.

Remarks: Significant sand/sediment deposit from 36" culvert on Aepovista Pl; no redox features observed.

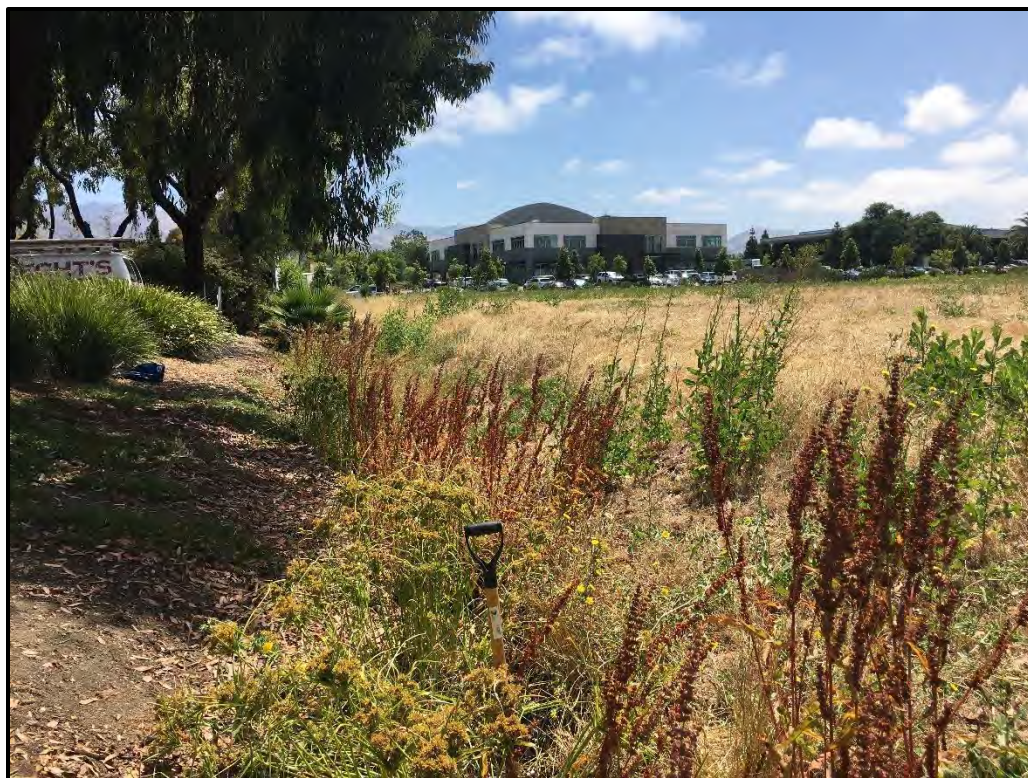
Photo 13. Sampling point (SP-03) within narrow channel at northern boundary of Survey Area
(Aspect: East)
