**Waters and Wetlands Delineation Report**  
**Aero Drive Hotel Project**  
**950 and 990 Aero Drive, San Luis Obispo, California**

**February 2020**

## EXECUTIVE SUMMARY

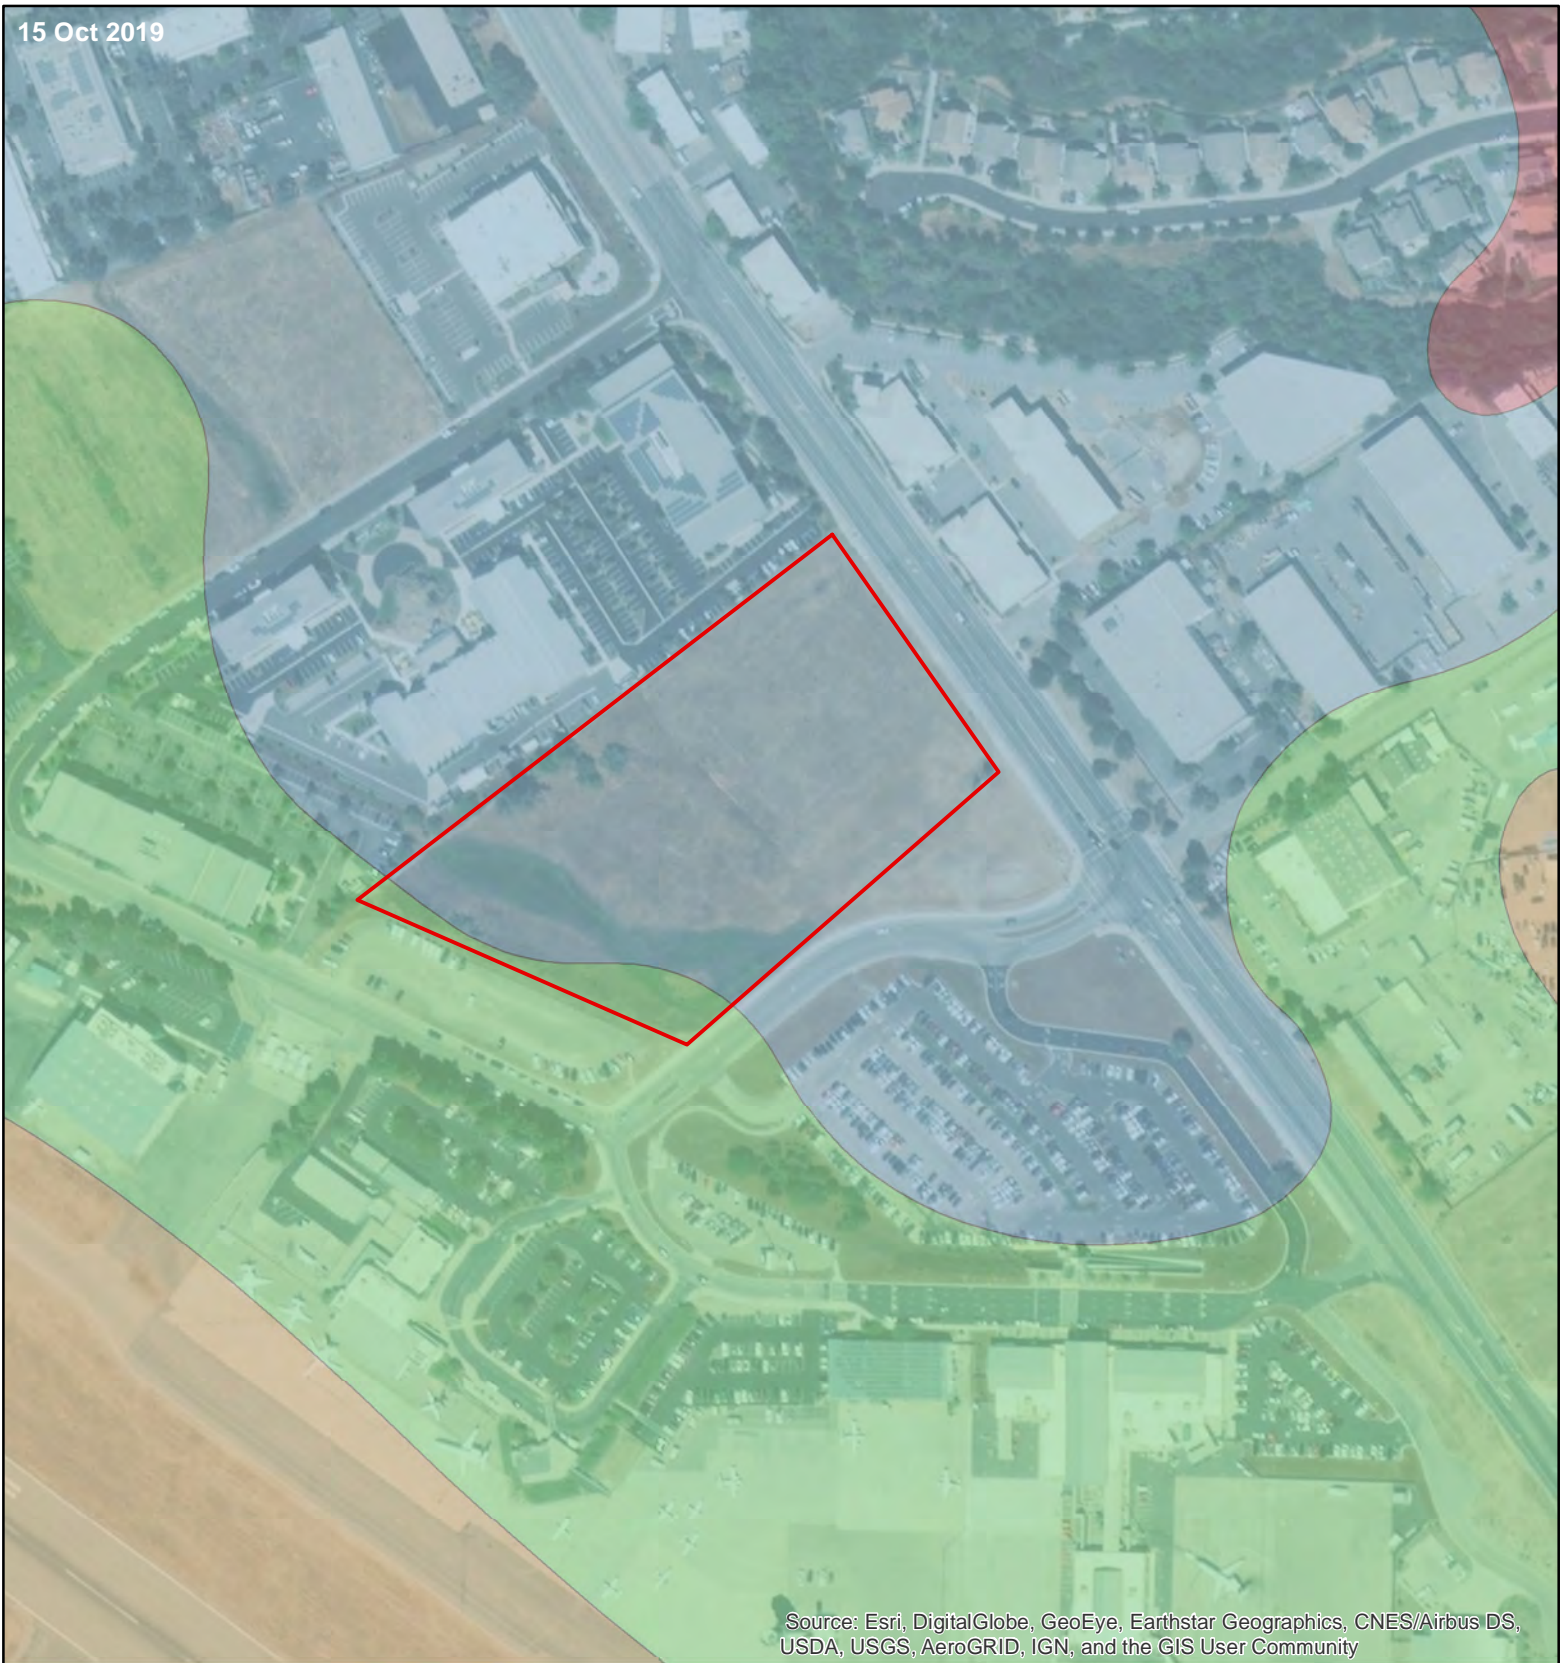
**Aero Drive Hotel Wetland Delineation  
Figure 4: Soils Units Map**

Tierra sandy loam, 2 - 9% slopes

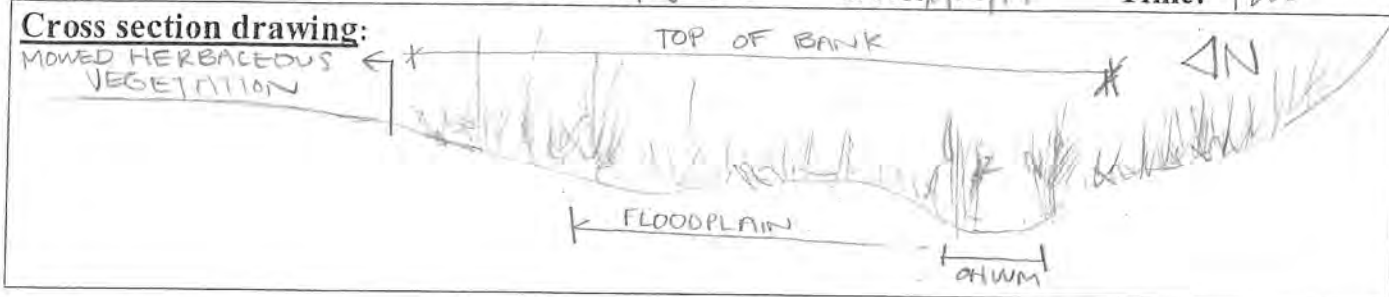
**OHWM**

Pool is scoured to a depth below the elevation of the low flow channel in immediately downstream area.

GPS point: AD-02

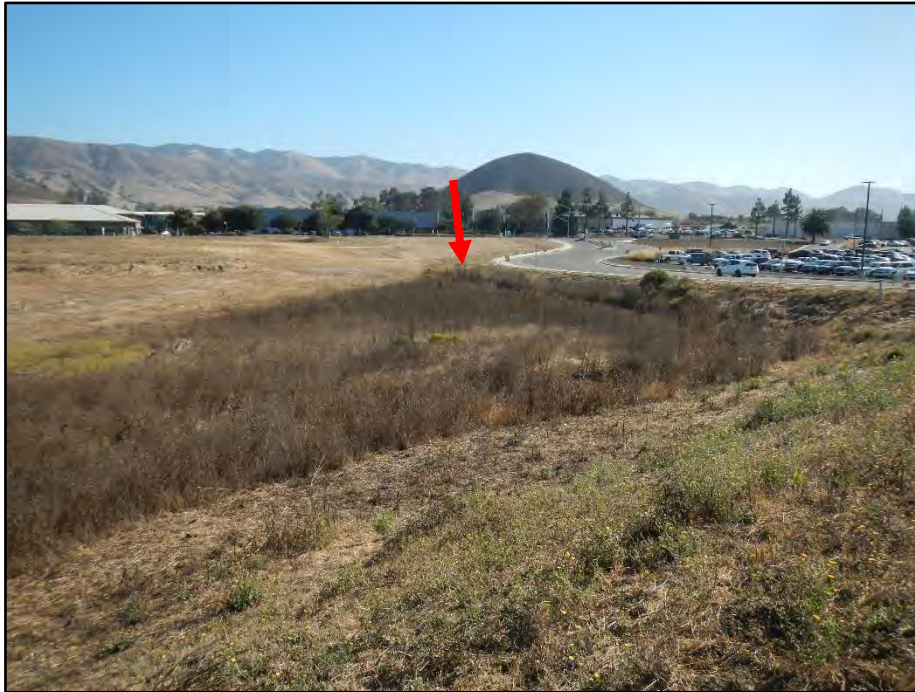
**Photo 1.** View east of drainage where it enters the survey area through a culvert (red arrow) under Aero Drive (10-03-19).

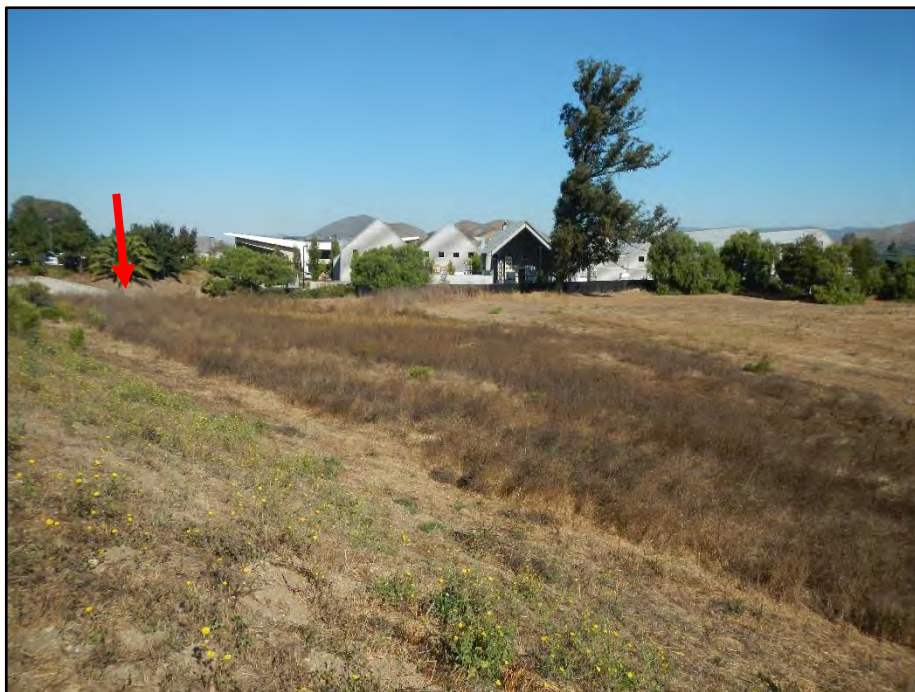
**Photo 2.** View north of downstream end of drainage where it flows northwest through the survey area and exits via a culvert (red arrow) (10-03-19).

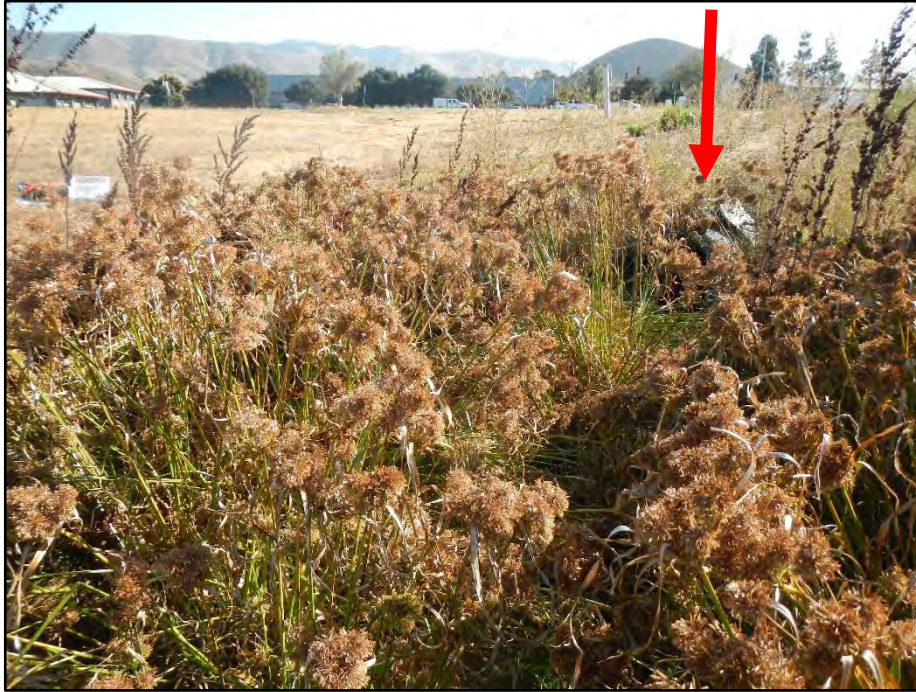
**Photo 3.** View of culvert under Aero Drive (red arrow) where drainage enters the survey area, aspect northeast (10-03-19).

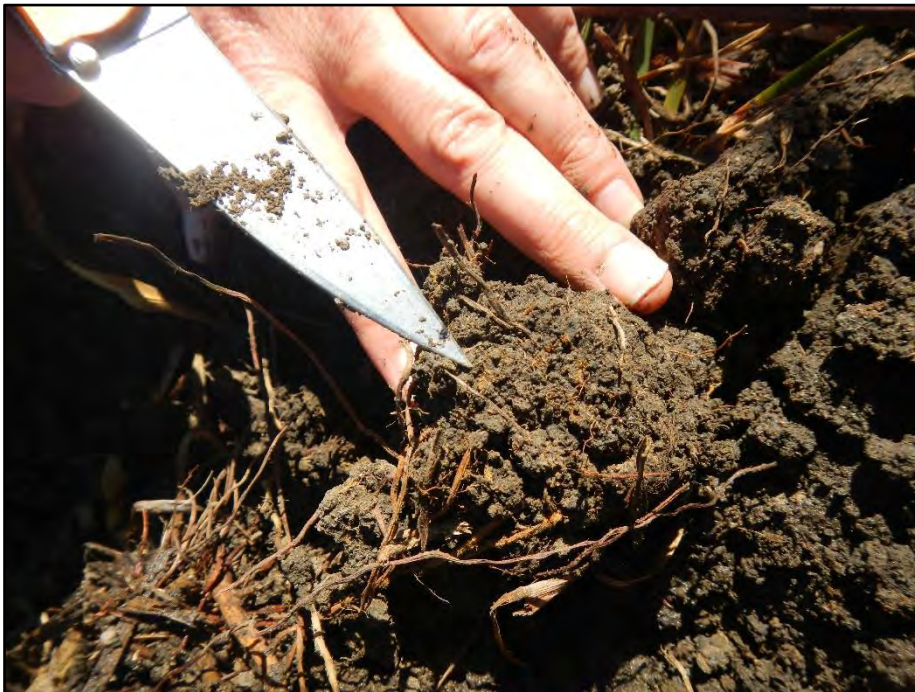
**Photo 4.** Soil ped from SP-02, showing redox features as concentrations in the matrix and oxidized pore linings along root channels (05-15-18).

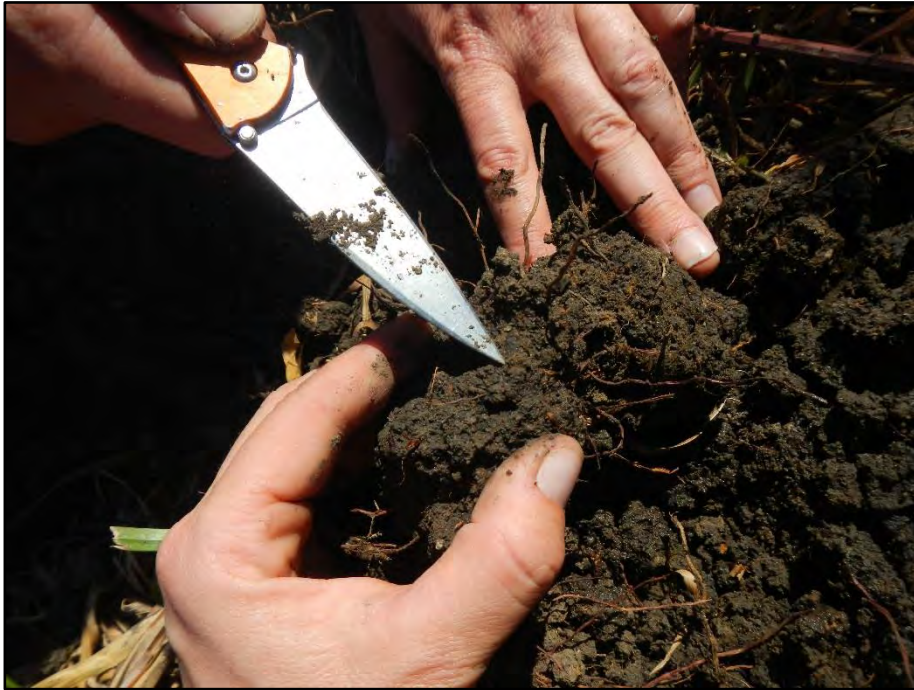
**Photo 5.** Soil ped from SP-03, showing redox features as oxidized pore linings along root channels (05-15-18).

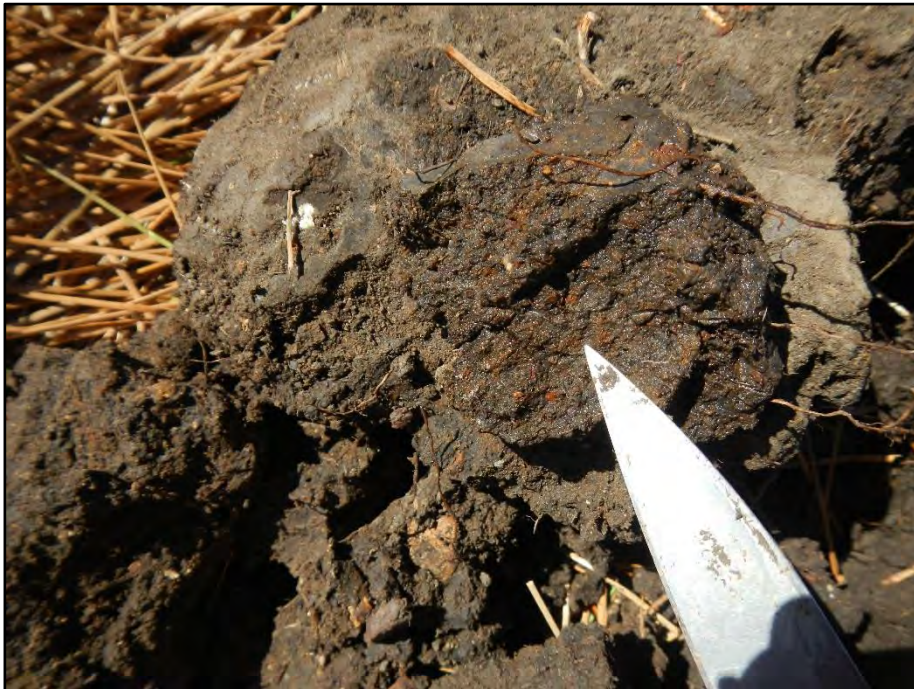
**Photo 6.** Soil plug from SP-05, showing redox features as oxidized pore linings along root channels (05-15-18).

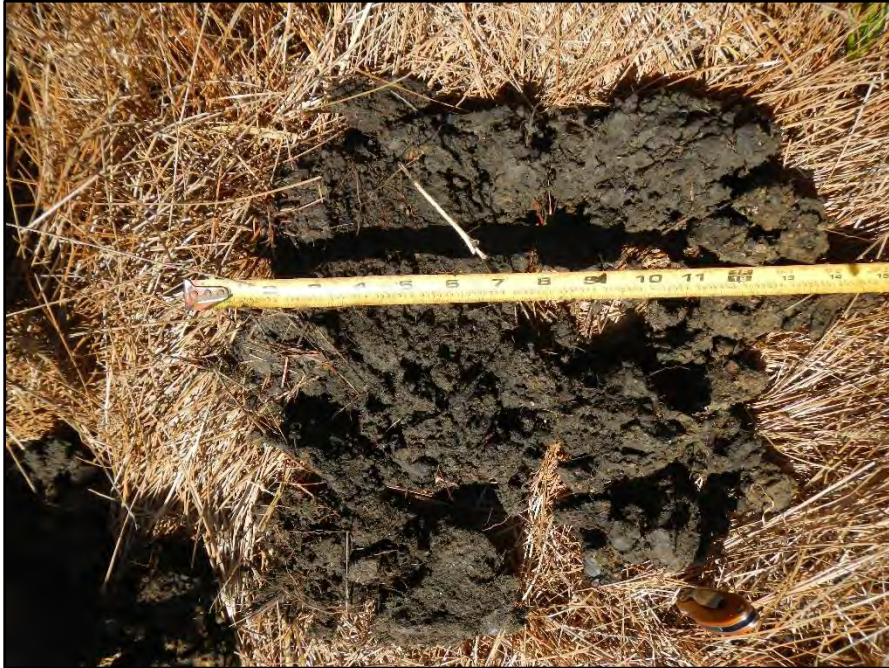
**Photo 7.** Soil plug from SP-07, lacking any redox features (10-03-19).

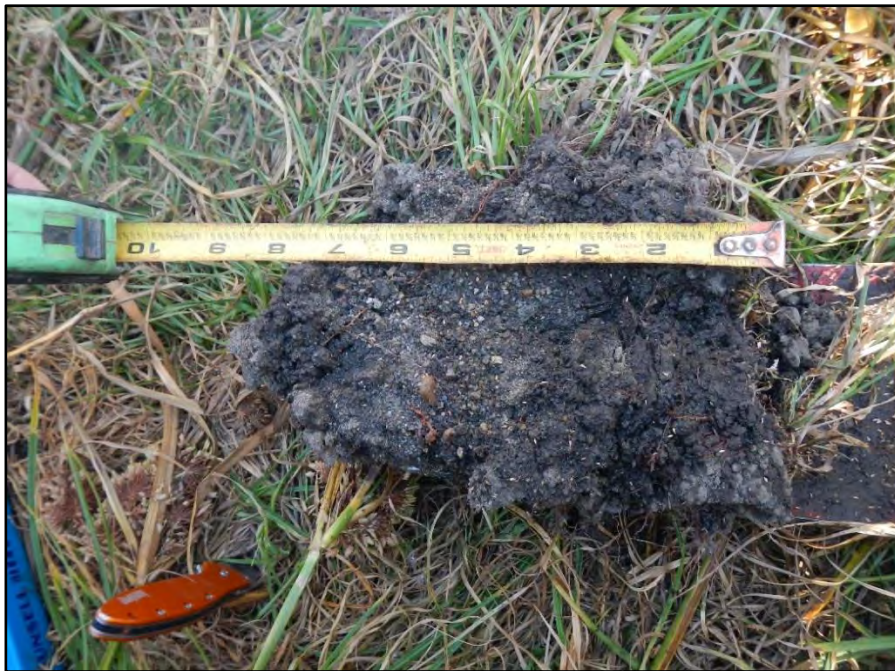
**Photo 8.** Soil plug from SP-01 showing deposited sand/decomposed granite, landscaping soil and woodchips that has runoff from adjacent developed areas (03-23-18).

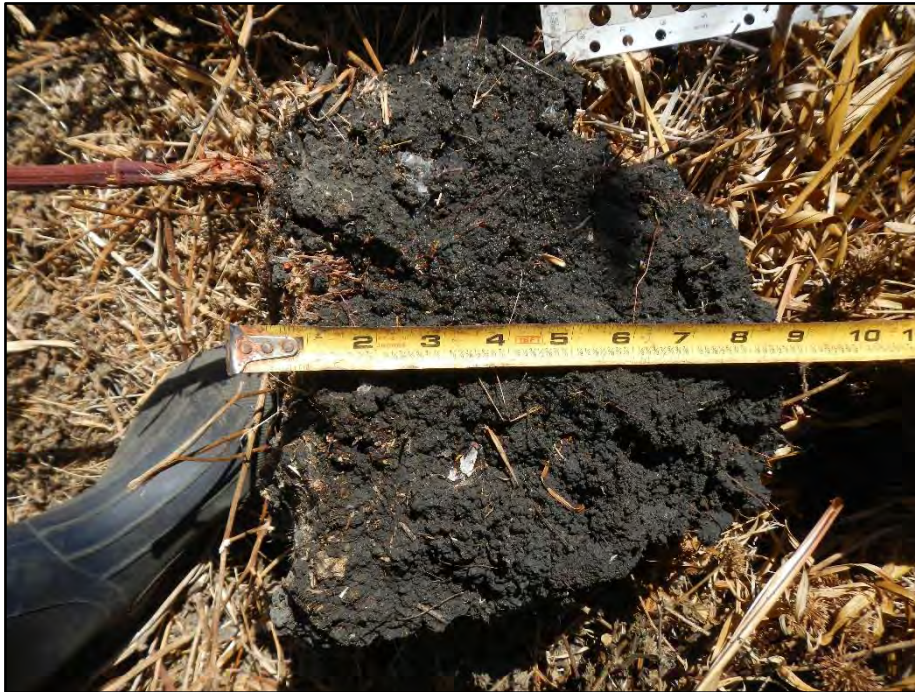
**Photo 9.** Soil plug from SP-04, lacking any redox features (10-03-19).

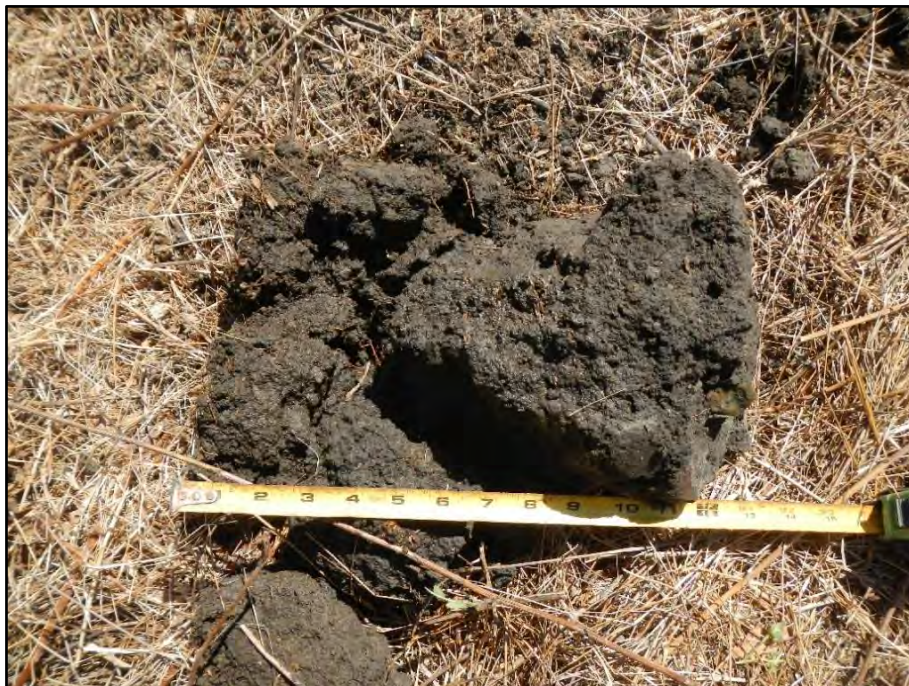
**Photo 10.** Soil plug from SP-06, lacking any redox features (10-03-19).
