# 7 AIR TRAFFIC OVER-FLIGHT

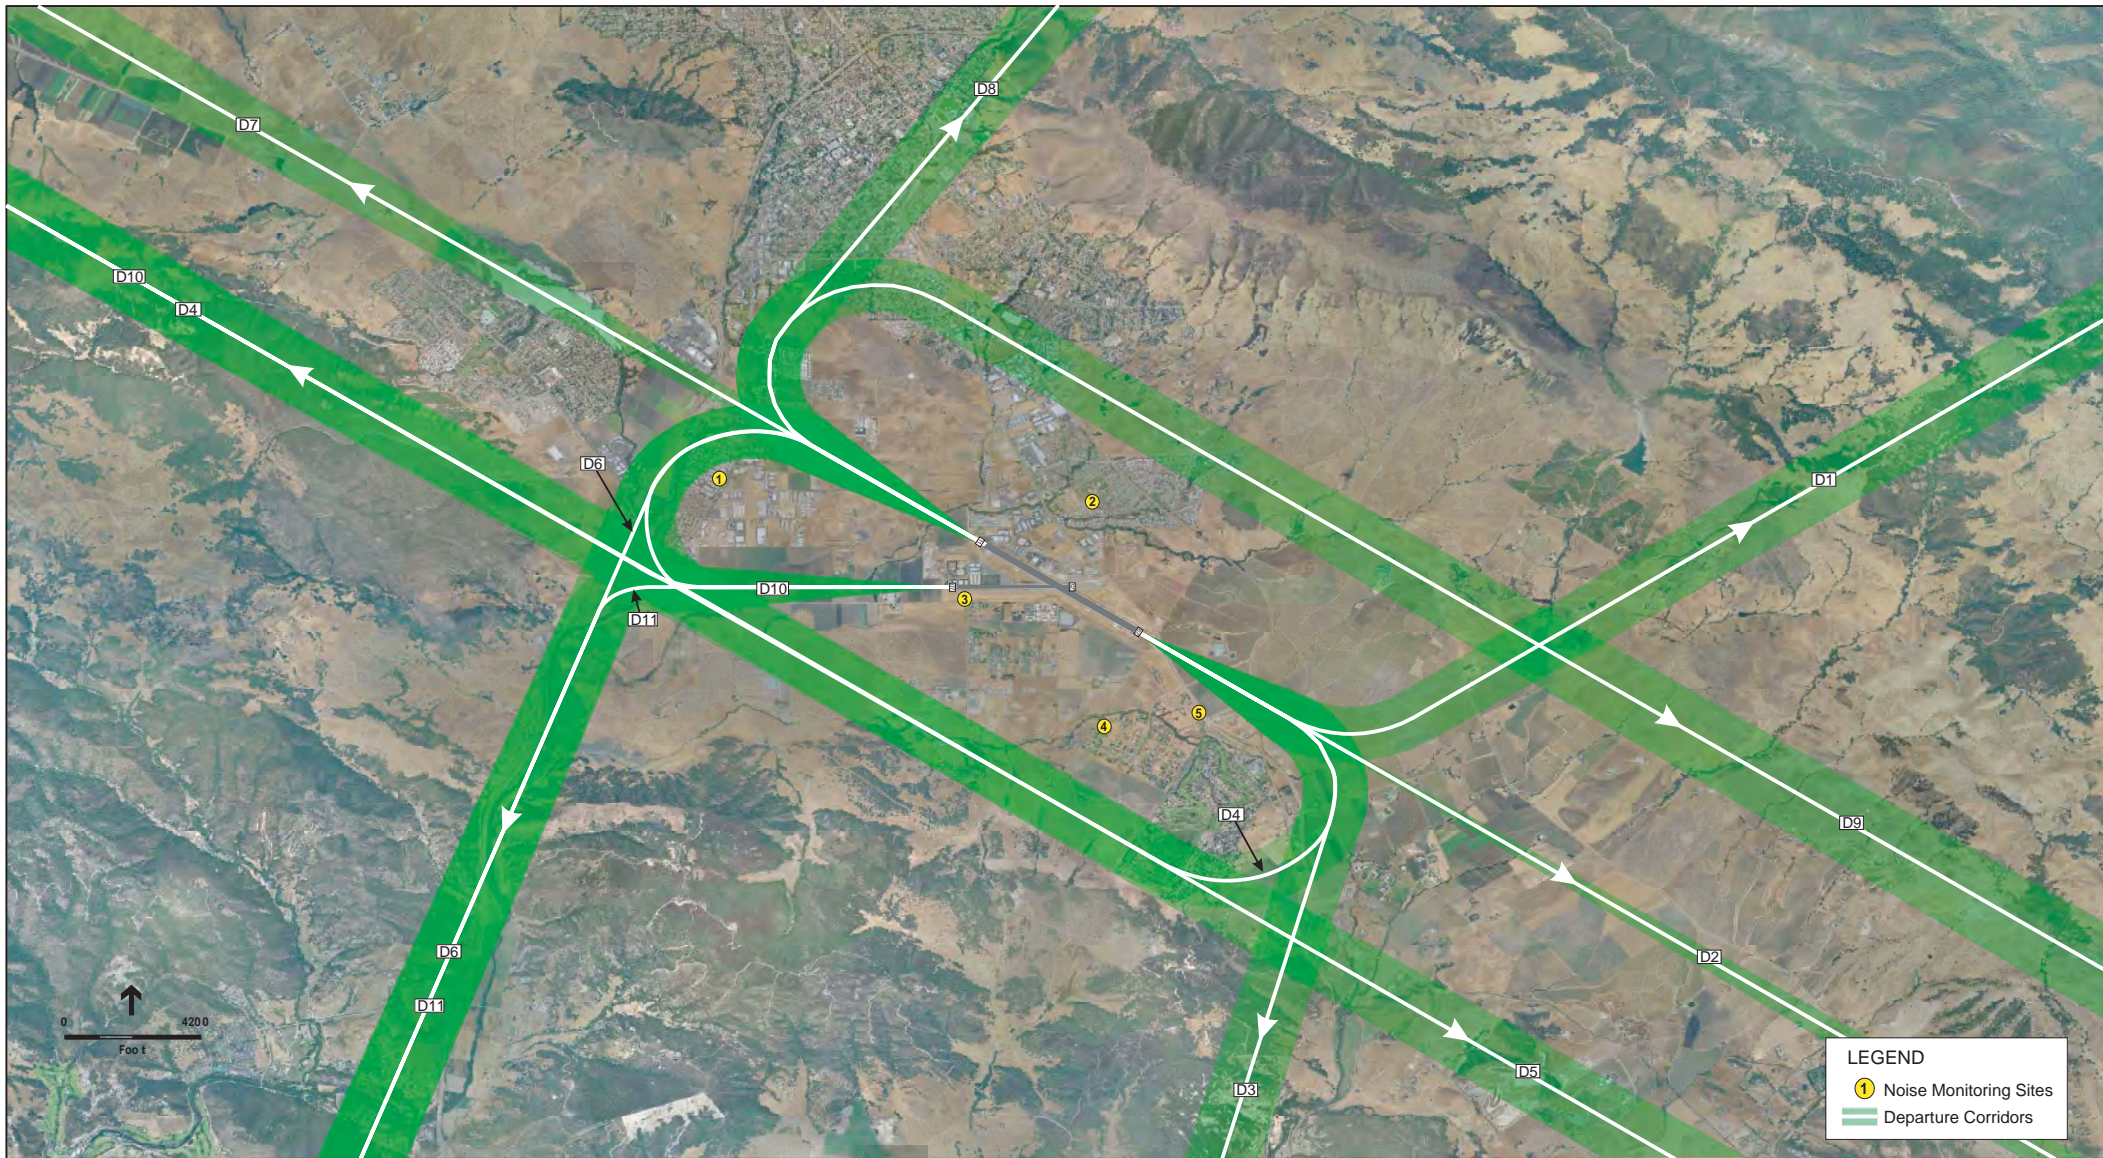
Figure 7-1 - SBP Departure Tracks used for EA/EIR Noise Modeling

*Figure 7-1* shows the generalized departures tracks, and *Figure 7-2* shows the generalized arrival and local pattern flight tracks that were used for noise modeling. Since noise modeling is confined to an area that is within the immediate Airport vicinity, the locations of assumed aircraft flight tracks at greater distances from the Airport were not analyzed or depicted.

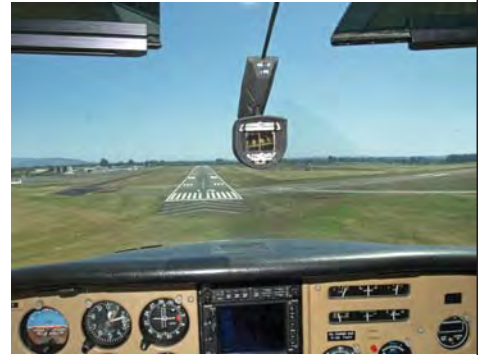
SHORT FINAL

- Normal Maneuvers:
  - Aircraft on very close final approach or departure – very high risk
- Altitude
  - Less than 200 feet above runway
- Common Accident Types
  - Arrival: Downdrafts and wind gusts. Low glide paths
  - Departure: Runway overruns, aborted takeoffs and engine failures
- Risk Level
  - Very high
- Percentage of near-runway accidents in this zone: 20% - 21%

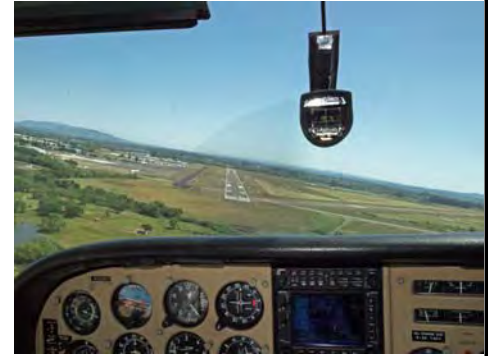
FINAL APPROACH

- Normal Maneuvers
  - Aircraft overflying at low altitudes on final approach and straight-out departures
- Altitude
  - Between 200 and 400 feet above runway
- Common Accident Types
  - Arrival: Similar to Zone 1, aircraft under-shooting approaches, forced short landings
  - Departure: Similar to Zone 1, emergency landing on straight-out departure
- Risk Level
  - High
  - Percentage of near-runway accidents in this zone: 8% - 22%

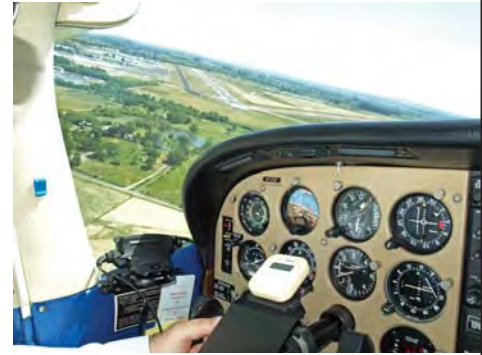
TURNING TO FINAL

- Normal Maneuvers
  - Aircraft—especially smaller, piston-powered aircraft— turning base to final on landing approach or initiating turn to en route direction on departure
- Altitude
  - Less than 500 feet above runway, particularly on landing
- Common Accident Types
  - Arrival: Pilot overshoots turn to final and inappropriately cross controls the airplane rudder and ailerons while attempting to return to the runway alignment causing stall, spin, and uncontrolled crash
  - Departure: Mechanical failure on takeoff; low altitude gives pilot few options on emergency landing site; or, pilot attempts to return to airport and loses control during tight turn
- Risk Level
  - Moderate to high
  - Percentage of near-runway accidents in this zone: 4% - 8%

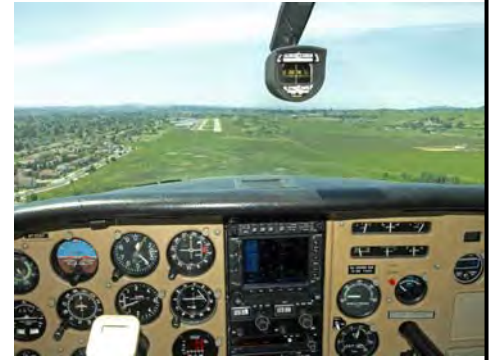
LONG FINAL

- Normal Maneuvers
  - Approaching aircraft usually at less than traffic pattern altitude. Particularly applicable for busy general aviation runways (because of elongated traffic pattern), runways with straight-in instrument approach procedures, and other runways where straight-in or straight-out flight paths are common
- Altitude
  - Less than 1,000 feet above runway
- Common Accident Types
  - Arrival: Pilot undershoots runway during an instrument approach, aircraft loses engine on approach, forced landing
  - Departure: Mechanical failure on takeoff
- Risk Level
  - Moderate
  - Percentage of near-runway accidents in this zone: 2% - 6%

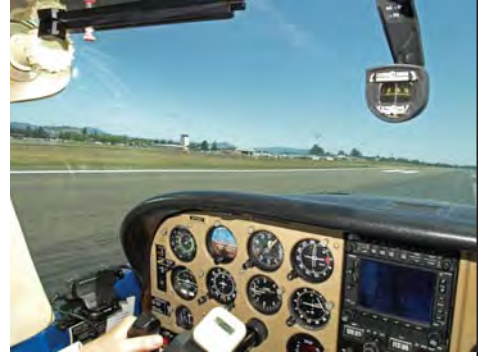
INITIAL LIFT-OFF OR LANDING TOUCHDOWN

- Normal Maneuvers
  - Area not normally overflown; primary risk is with aircraft (especially twins) losing directional control on takeoff, excessive crosswind gusts or engine torque
- Altitude
  - Runway elevation
- Common accident types
  - Arrival and Departure: Aircraft losing directional control and veering off the side of the runway
- Risk Level
  - Low to moderate
  - Percentage of near-runway accidents in this zone: 3% - 5%

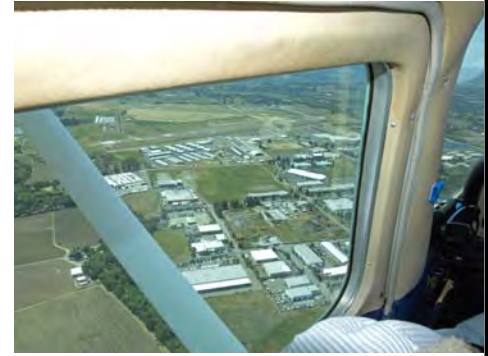
IN TRAFFIC PATTERN

- Normal Maneuvers
  - Aircraft within a regular traffic pattern and pattern entry routes
- Altitude
  - Ranging from 1,000 to 1,500 feet above runway
- Common Accident Types
  - Arrival: Pattern accidents in proximity of airport
  - Departure: Emergency landings
- Risk Level
  - Low
  - Percentage of near-runway accidents in this zone: 18% - 29% (percentage is high because of large area encompassed)

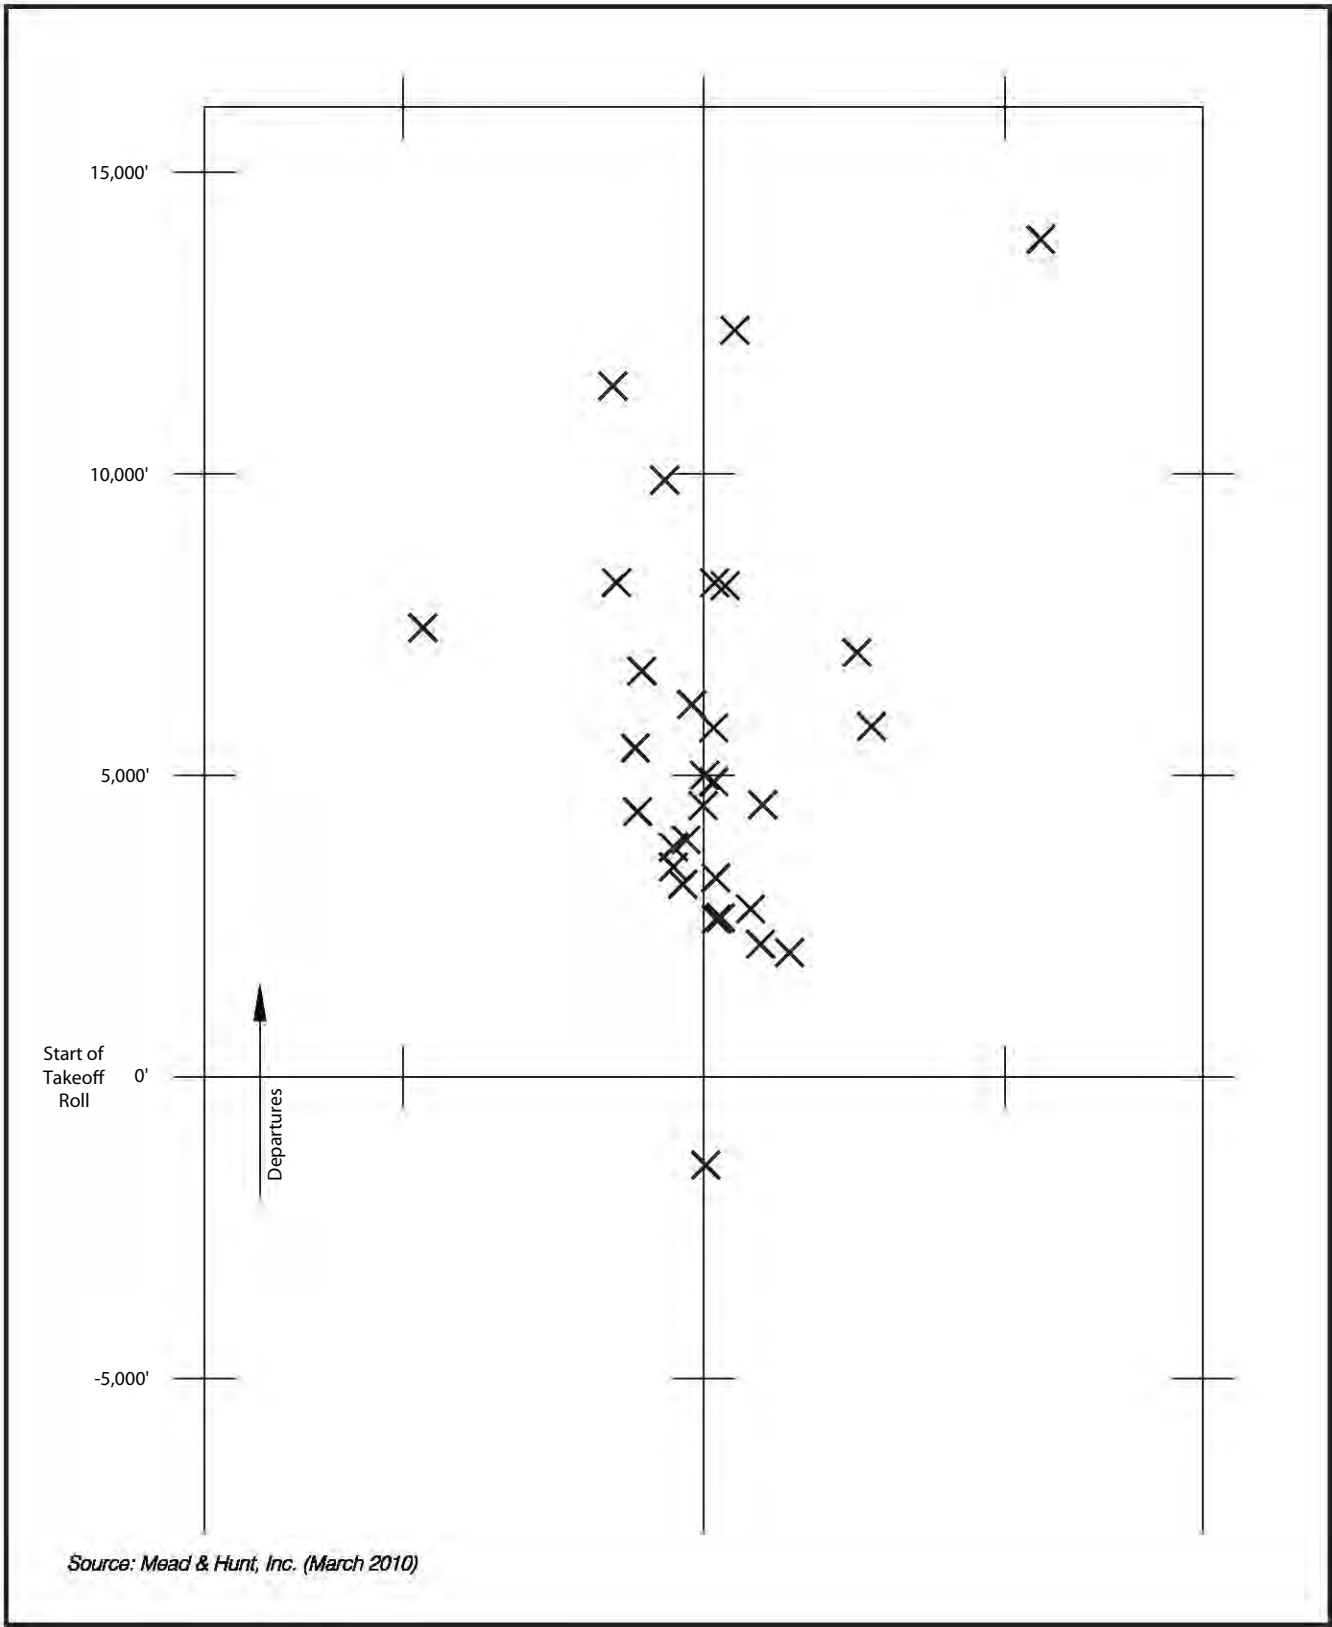
FIGURE E2

All Categories – Departure Accidents (2002 Handbook Data)

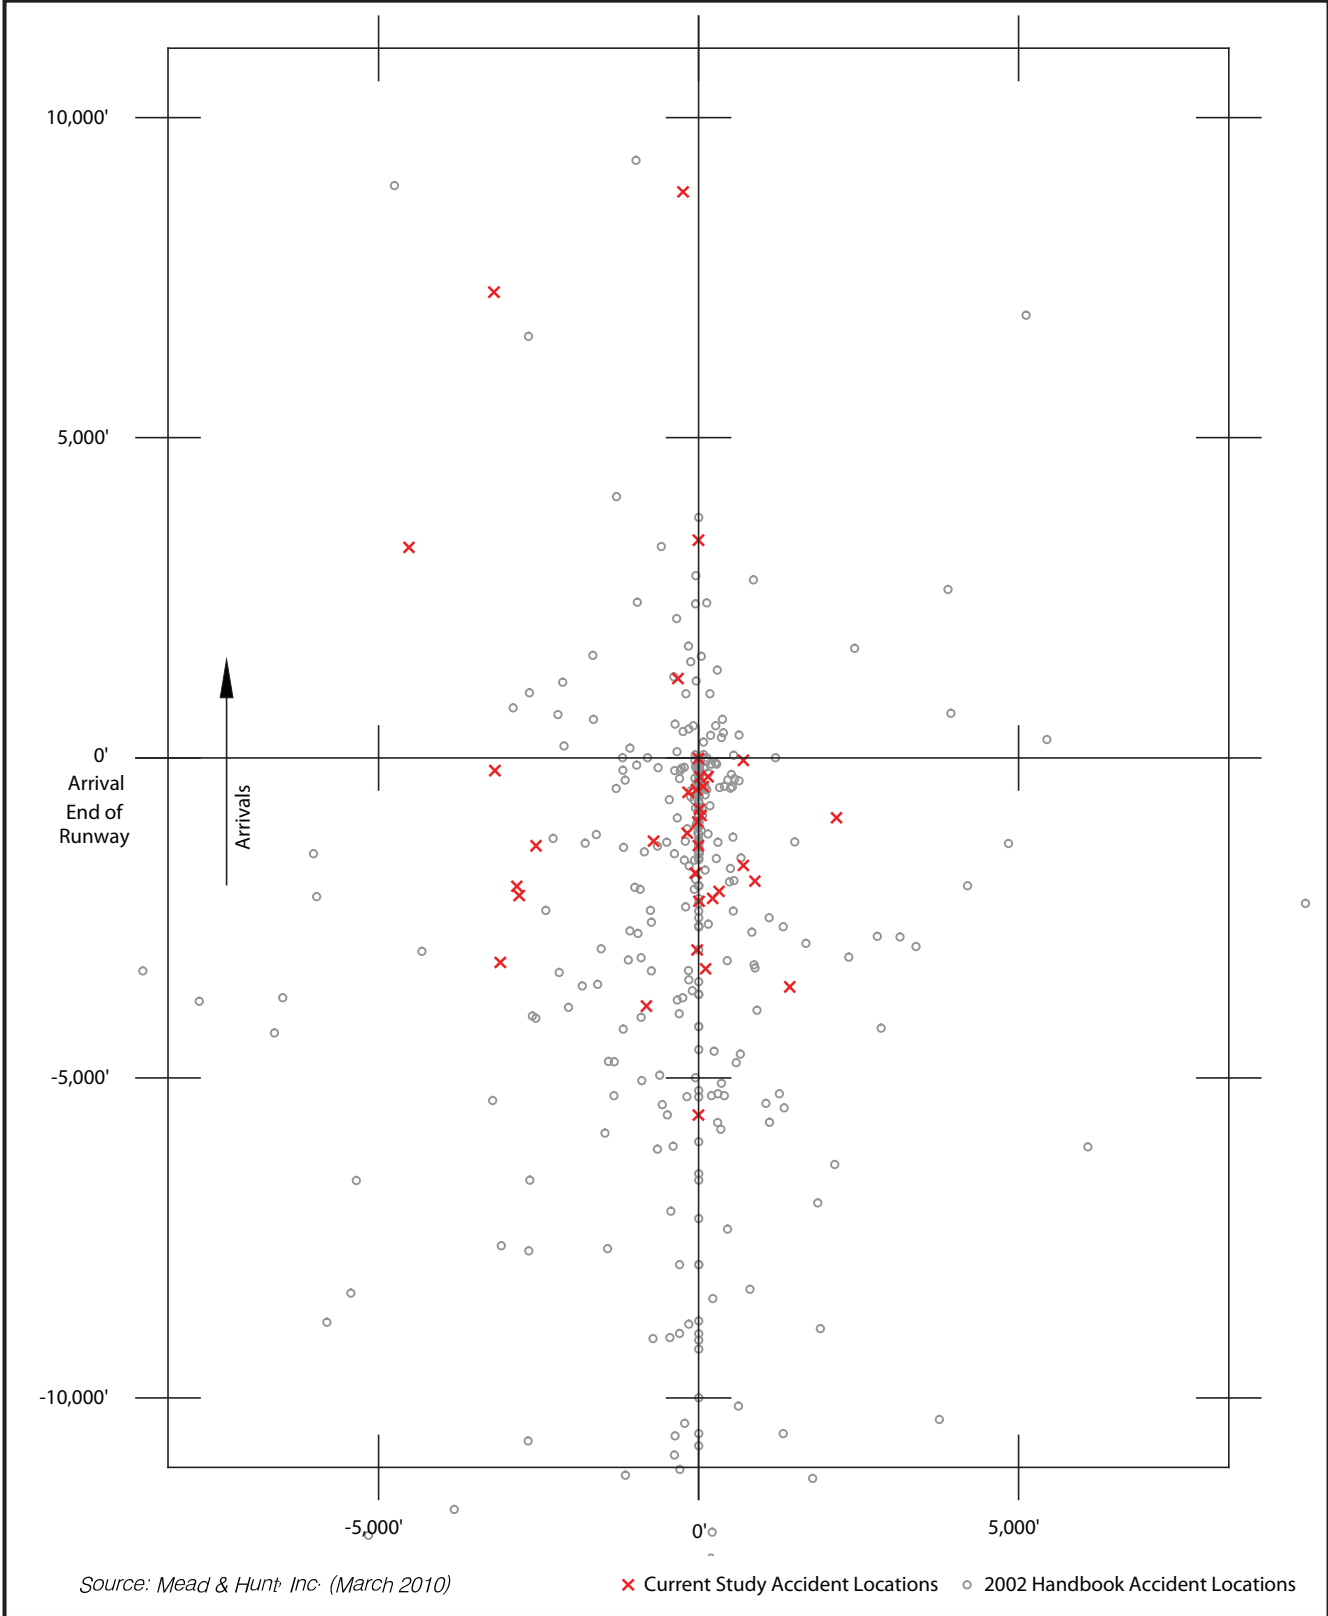
EXHIBIT E1

### All Categories – Arrival Accidents

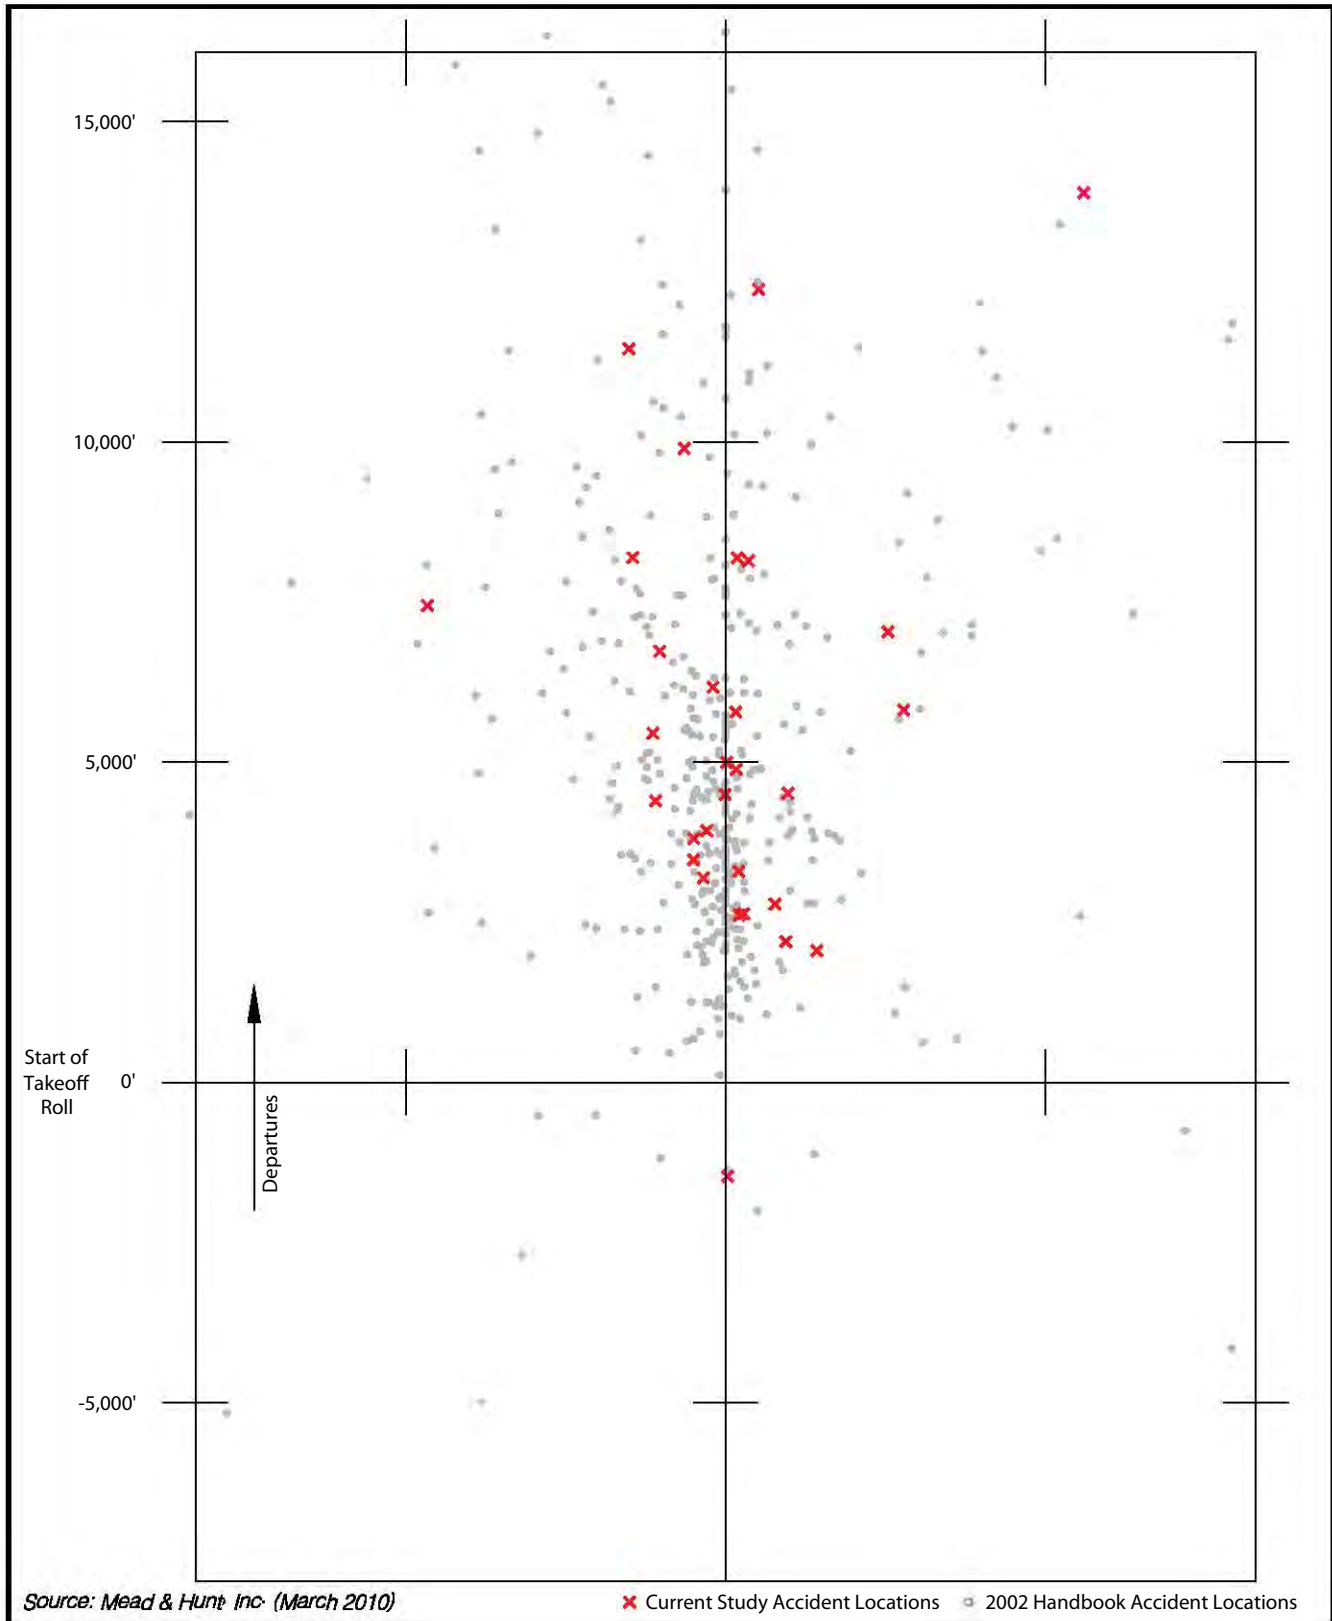
EXHIBIT E2

### All Categories – Departure Accidents

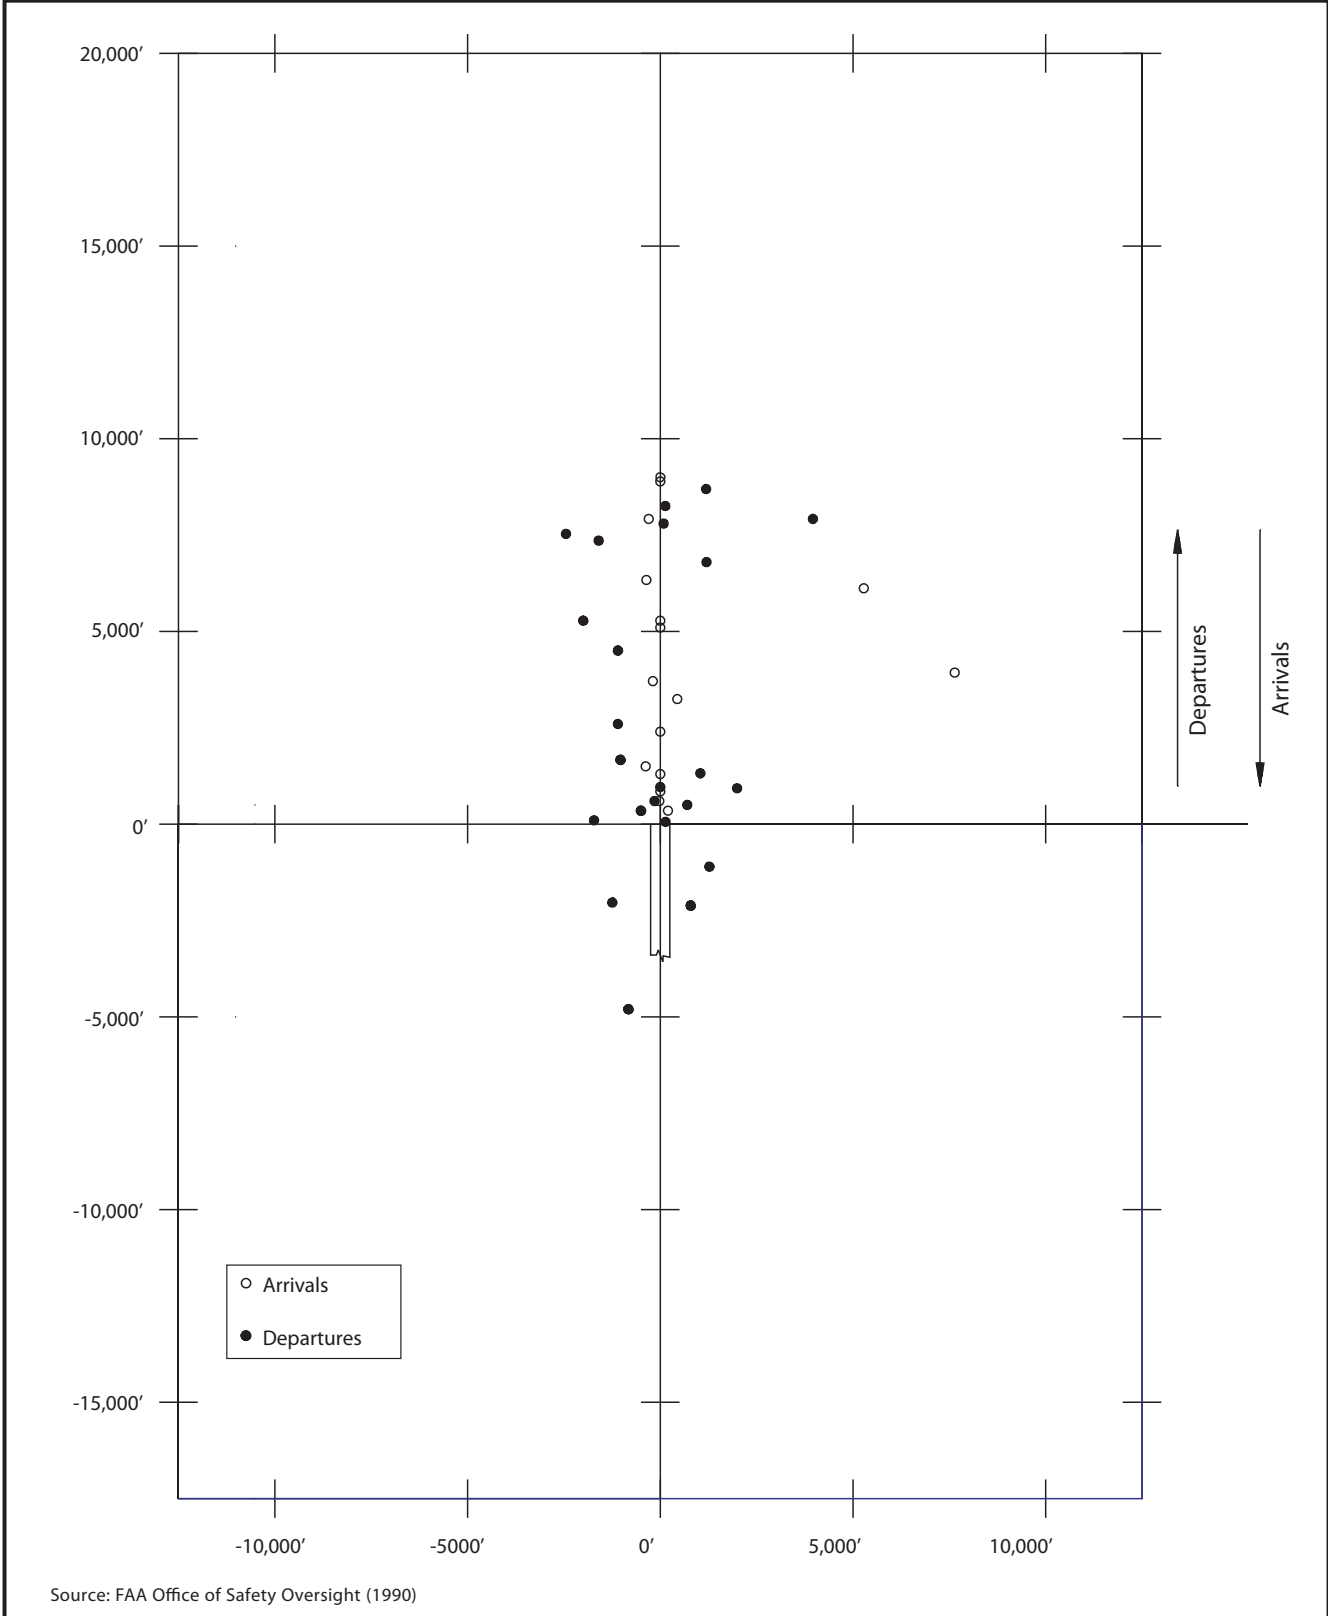
FIGURE E6

### Commercial Aircraft Accident Location Pattern
